Interior A-Pillar Trim Deformation

Service Category Vehicle Interior

Section Interior Panels/Trim

YEAR(S)	MODEL(S)	ADDITIONAL INFORMATION
2012 – 2013	Camry, Camry HV

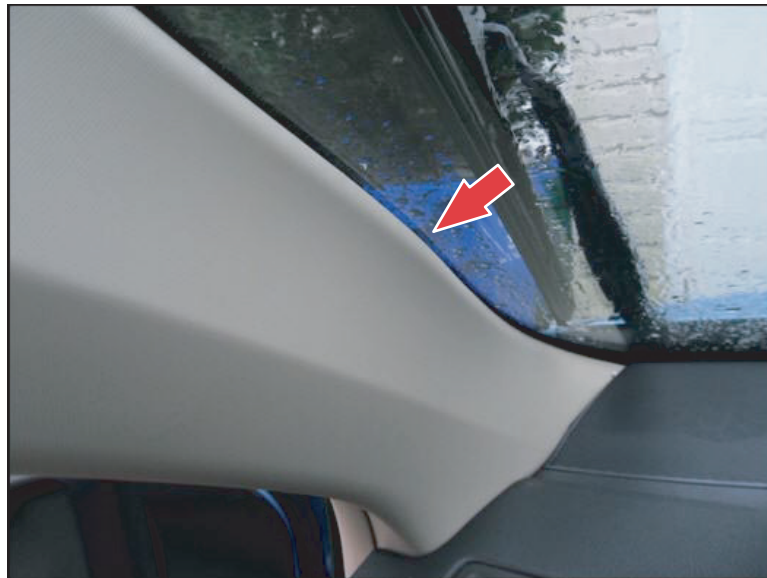
Some 2012 – 2013 model year Camry and Camry HV vehicles may exhibit a bowing or deformation of the interior A-Pillar trim along the windshield. Use the following procedure to replace the interior A-Pillar trim garnish and address this condition.
