Rear A/C Refrigerant Line Clamp Separation

2011-2013 Highlander, Sienna and Sequoia

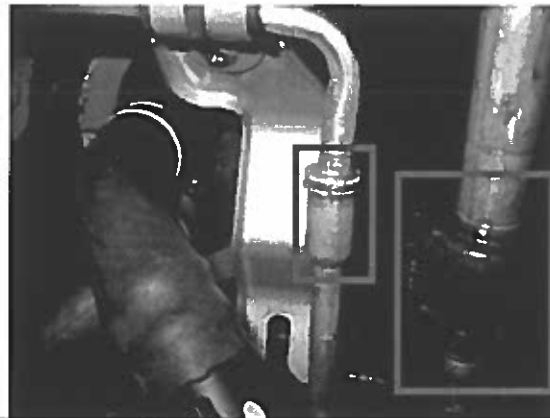
On some Highlander, Sienna, and Sequoia vehicles, a plastic clamp connecting the rear A/C lines may become loose. This may allow separation of the A/C lines and a loss of refrigerant.

This issue is currently under investigation. If you find a vehicle that meets the following criteria below, DO NOT attempt to repair. Contact TAS for further diagnostic instructions:

1. Low refrigerant in A/C system.
2. Plastic line clamp missing, loose, or not fully engaged.
