ECU Software Update: Charging System Improvement

Section Hybrid/Battery Control System

YEAR(S)	MODEL(S)	ADDITIONAL INFORMATION
2012 – 2013	RAV4 EV

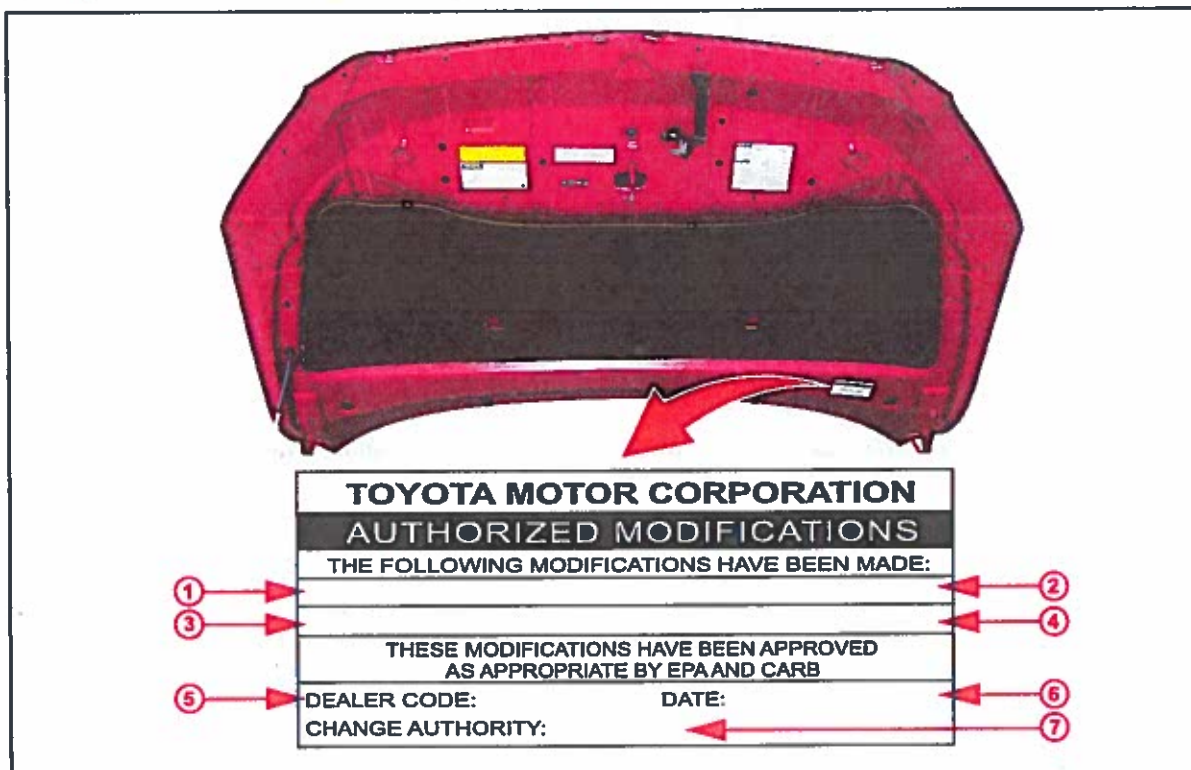
Figure 1. Location of Authorized Modifications Label on 2012 – 2013 RAV4 EV

1	Replacement Power Management Control ECU Part Number (i.e., 89690-42015)
2	Replacement EV Gateway Control ECU Part Number (i.e., 89881-0R011)
3	New Calibration ID of Power Management Control ECU (i.e., 896B34201500)
4	New Calibration ID of EV Gateway Control ECU (i.e., 1.3.79)

5	Dealer Code
6	Date Completed
7	This SB Number

1. Check for the Authorized Modifications Label affixed to the vehicle in the location shown in Figure 1. Confirm if the ECU calibrations have been updated. If the calibration IDs listed are NOT the latest ECU calibrations — go to step 2.
