ABS Brake Noise with DTC C1431

Service Category Brake

Section Brake System

| YEAR(S) | MODEL(S) | ADDITIONAL INFORMATION |
|---|---|---|
| 2012 – 2013 | Camry | |

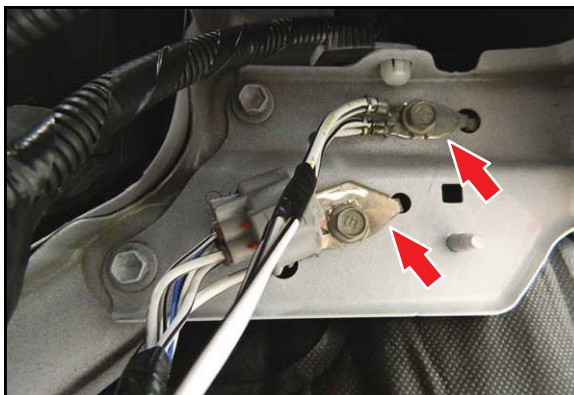
Figure 1.

- [2012](#) / [2013](#) Camry:
Brake – Brake Control/ Dynamic Control Systems – “Vehicle Stability Control System: C1430, C1431; Brake Pedal Load Sensing Switch OFF Stuck Malfunction”
2. If the brake pedal load sensing switch is judged OK, check the resistance at connector A40 Pin 1 to body ground. Is the resistance always below 1 ohm?
 - **YES** – Continue diagnosis using the Repair Manual.
 - **NO** – Proceed to step 3.
 3. With the battery connected, perform voltage drop test from the two left fender bracket ground wire eyelet tabs to body ground (see Figure 1).

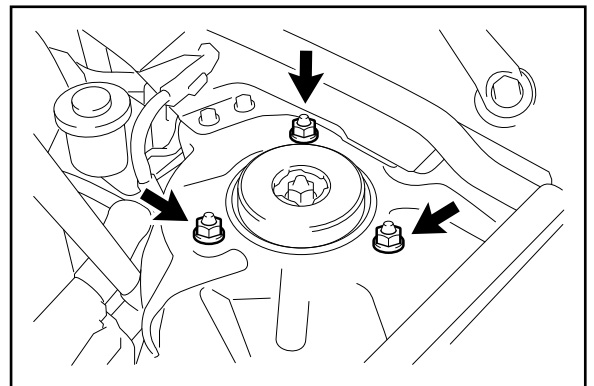
Figure 2.

- A. Use a left front strut tower mounting bolt as a good body ground (see Figure 2).

- B. To perform voltage drop test, connect the negative lead of the DVOM to the strut tower bolt, and the positive lead to the ground wire eyelet tab.

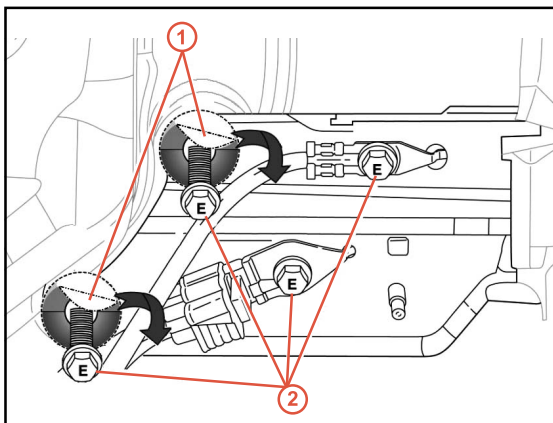
Figure 3.

4. Is voltage drop from each ground location less than 0.2 volts?
 - **YES** – Continue diagnosis using the applicable Repair Manual.
 - **NO** – A voltage drop of 0.2 volts or more from either of the ground locations may indicate poor continuity in the ground circuit. Proceed to step 5.
5. With the battery disconnected, remove the left hand fender bracket from the apron for inspection.
6. Inspect the grounds on the left hand fender bracket. Confirm the following:
 - Ground bolts are “E” bolts (see Figures 3 and 5).
 - Apron bolts should be “E” bolts if left hand fender bracket has been replaced (see Figures 3 and 5).
 - The area around the bracket to apron mounting bolt holes (see Figure 4) is free of paint.
 - The area around the apron mounting bolt holes do not show masking tape or painted masking tape (see Figures 3 and 4).

| 1 | Confirm Green Masking Tape Is Removed |
| 2 | Confirm “E” Bolts Are Installed |

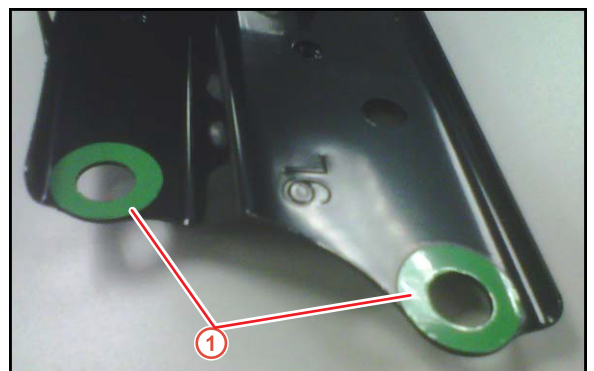
Figure 4.

| 1 | Masking Tape — REMOVE After Painting, NO Paint in This Area |

- **NO** — Replace the left hand fender bracket.
- **YES** — Remove the tape or paint and continue to step 8.

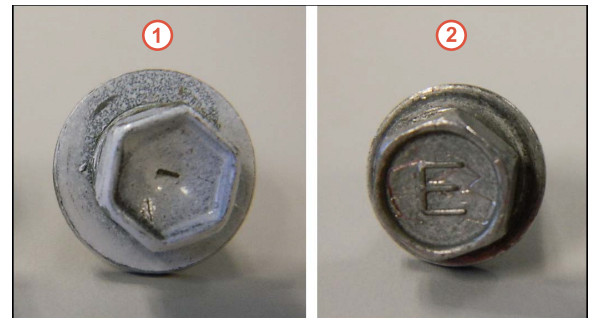
Figure 5.

- It is important that the bracket to apron mounting bolts/washers are free of paint on the front portion of the bracket.
- The new part number bracket comes with instructions that should be followed carefully when replacing.
- The new bracket also comes with green tape around the apron mounting bolts to protect it during the painting phase (see Figures 3 and 4). *This green masking tape MUST be removed in order for the bracket to be properly installed on the vehicle.*
- The new bracket includes new apron "E" mounting bolts. It is important that the new "E" bolts are used and are torqued properly. See Figure 5 on how to identify new bolts.

| 1 | Old Bolt: DO NOT USE or Reuse These Bolts |
| 2 | NEW "E" Bolt |

Torque: Ground Bolts:
6.9 – 9.8 N*m (70 – 100 kgf*cm,
5.1 – 7.2 ft*lbf)

Torque: Bracket to Apron Bolts:
3.9 – 8.8 N*m (40 – 90 kgf*cm,
2.8 – 6.5 ft*lbf)
