Air Injection System MIL "ON"

Service Category Engine/Hybrid System

Section Engine Control

Some 2005 – 2009 model year 4Runner, 2006 – 2007 model year Land Cruiser, 2005 – 2007 model year Sequoia, and 2005 – 2006 model year Tundra vehicles equipped with the 2UZ-FE (4.7 L) engine may exhibit a MIL "ON" condition for the following Diagnostic Trouble Codes (DTCs):

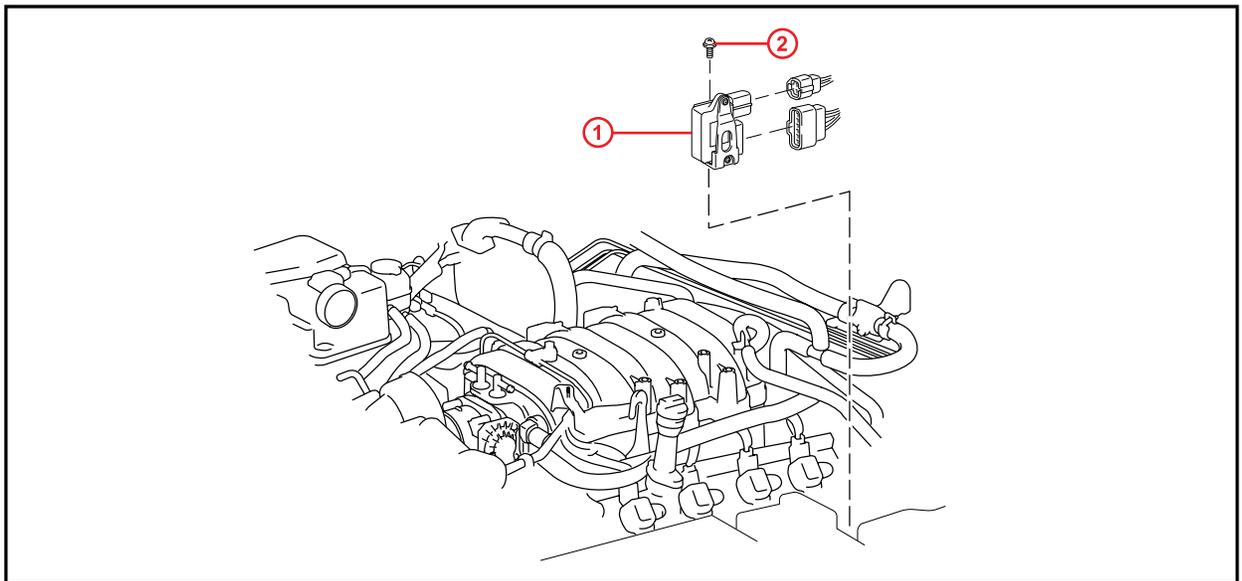
Figure 1.

1 Air Injection Control Driver

2 Specified Torque: 7.5 N*m (76 kgf*cm, 66 in*lbf)

- If MIL illuminates, or a DTC is detected, proceed to step 6.
 - If MIL does not illuminate, or a DTC is not detected, proceed to step 8.
6. Using Techstream, check for DTCs. If P0418 and/or P2445 are present, replace the Air Injection Control Driver.
