# Front Exhaust Pipe Catalyst Rattle Noise and/or MIL "ON" DTC P0420

YEAR(S)	MODEL(S)	ADDITIONAL INFORMATION
2010	Tacoma	VDS(s): NX4CN, NX4GN, PX4EN, TX4CN, TX4GN, UX4EN

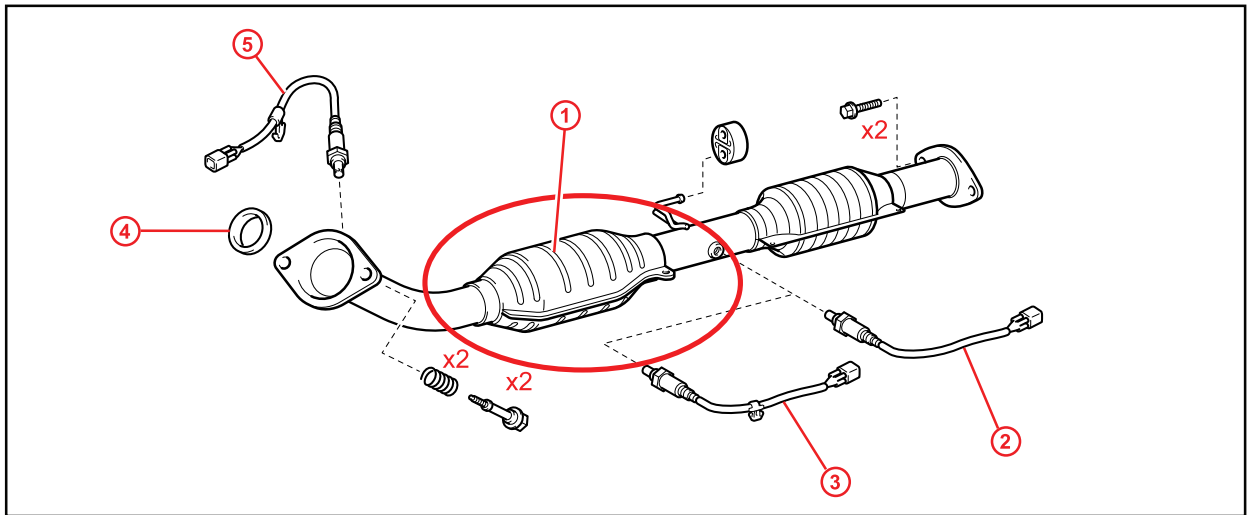
Figure 1. 2TR-FE Front Exhaust Pipe Components

- Increase the engine speed and listen to the catalytic converter section on the front exhaust pipe assembly for a rattle noise.

- Did the noise appear to be the loudest at the catalytic converter section of the front exhaust pipe assembly?
  - YES** — Continue to step 5.
  - NO** — This bulletin does NOT apply. Continue diagnosis using the applicable Repair Manual.
- Replace the front exhaust pipe assembly.

- 2010 Tacoma:  
*Engine/Hybrid Systems – Intake/Exhaust – “2TR-FE Exhaust: Exhaust Pipe: [Removal](#) / [Installation](#)”*
- Test drive vehicle to confirm repair.
