Moisture in Rear Combination Light / Water Intrusion Into Vehicle

Service Category Vehicle Exterior

Section Lighting (ext)

YEAR(S)	MODEL(S)	ADDITIONAL INFORMATION
2013	FR-S

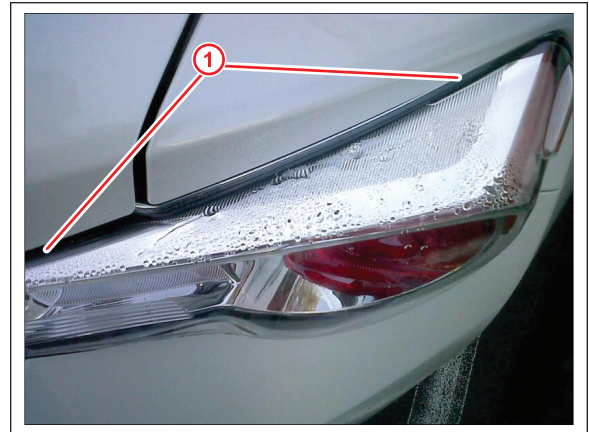
Figure 1.

1. Prior to making any repairs or replacing parts, locate the source of water entry.
2. See Figure 1 for an example of moisture inside the Rear Combination Light.

1	Interior Moisture
----------	--------------------------

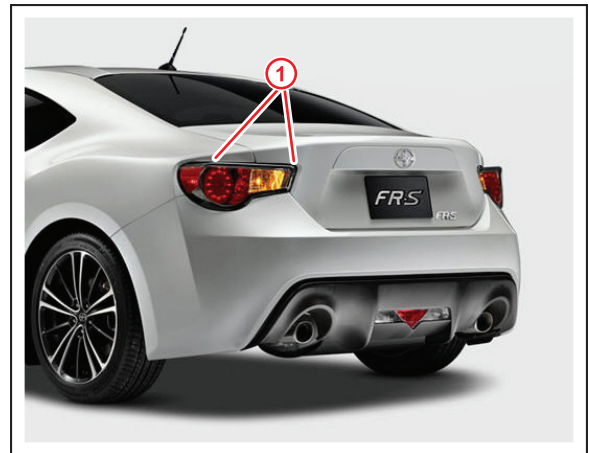
Figure 2.

1	Spray Location
----------	-----------------------

4. Spray water on the vehicle, especially around the perimeter of the light housing.

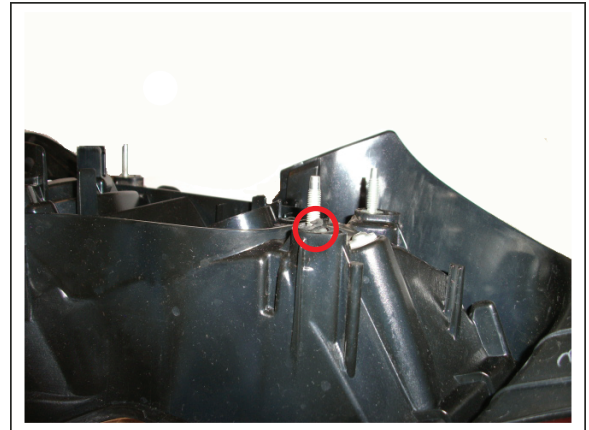
Figure 3.

6. Remove one or both lights that show evidence of moisture intrusion.
7. Inspect the back side of the combination lights for evidence of plastic cracking around the mounting studs. If cracking is present, replace the housing, gasket, and nuts.

- The sealing gasket is a “ONE USE ONLY” type gasket and **MUST** be replaced every time a combination light housing is removed from the vehicle.
- If servicing a rear combination light or gasket, be sure to replace the hardware with the **NEW** service parts (SU003-04650).

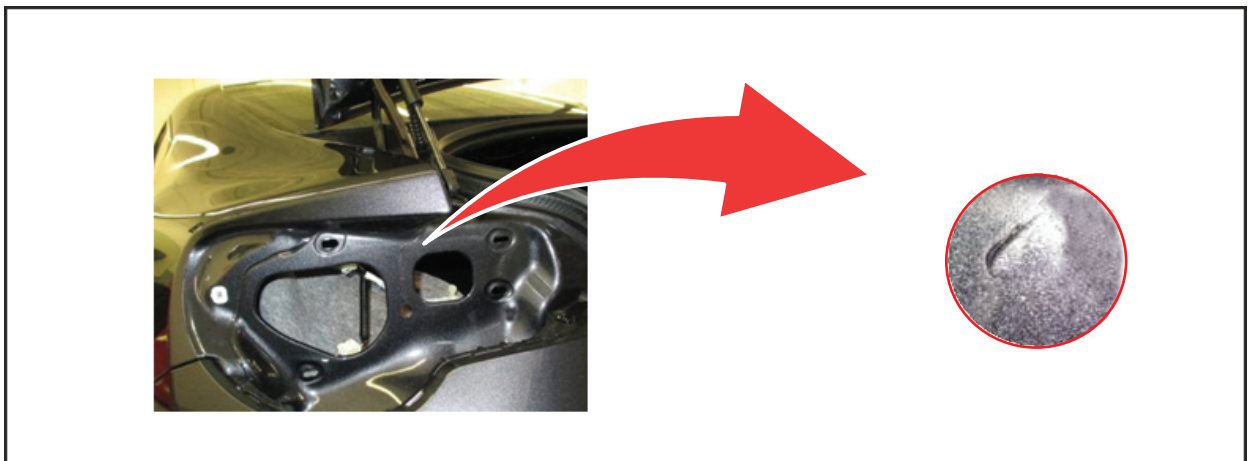
Figure 4.

1. Inspect the sheet metal body panel adjacent to the back side of the light housing for evidence of misplaced body seam sealer.

Remove any misplaced seam sealer with the sharp end of the plastic pry tool (SST# 00002-06002-01) being careful **NOT** to damage the painted body surface. If bare metal should appear during the sealer removal process, use touch-up paint to cover any bare metal areas before proceeding.

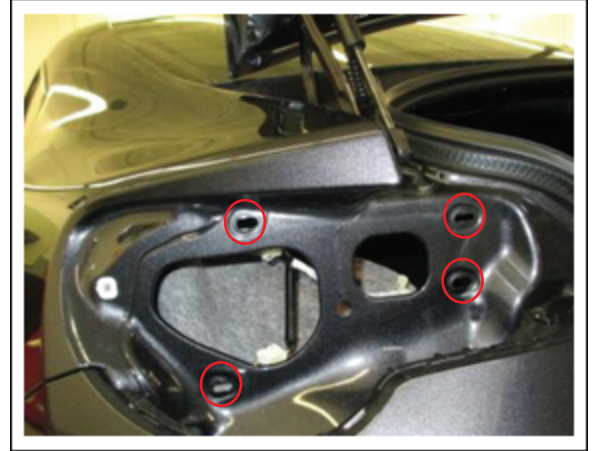
Figure 5.

2. Inspect the body sheet metal for evidence of deformed (cone shape) sheet metal around the 4 through-holes in the body.

Use a Body Hammer and Body Dolly to flatten the sheet metal around the 4 through-holes in the body (see circled areas for through-hole locations). Use touch-up paint on any bare metal areas.

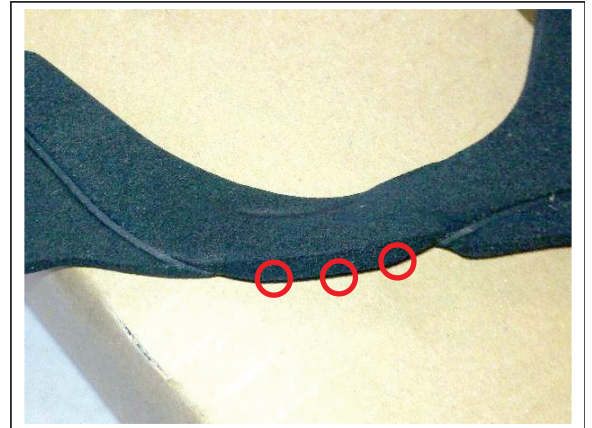
Figure 6.

3. Inspect the rear combination light sealing gasket for evidence of misplacement.

A misplaced gasket may allow water to enter the combination light housing or possibly the interior of the vehicle.

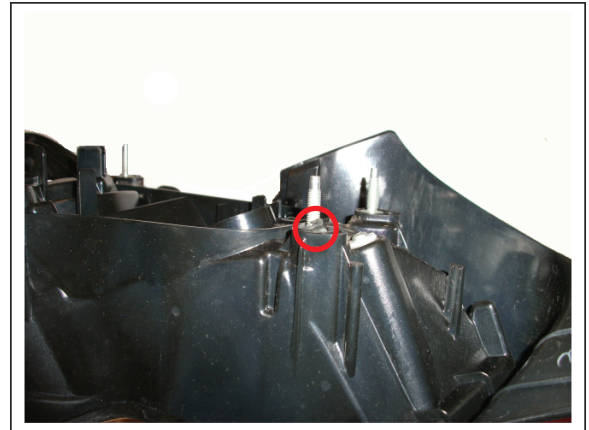
Figure 7.

4. Replace a rear combination light ONLY if it is damaged.

- If the cause of the water leak was misplaced seam sealer or a misplaced sealing gasket, carefully inspect the combination light housing for evidence of damage. If no damage is present, do NOT replace the housing, replace ONLY the sealing gasket.
- The sealing gasket is a “ONE USE ONLY” type gasket and **MUST** be replaced every time a combination light housing is removed from the vehicle.
- If servicing a rear combination light or gasket, be sure to replace the hardware with the **NEW** service parts (SU003-04650).
