Creak Noise from Sunroof While Driving

Service Category Vehicle Exterior

YEAR(S)	MODEL(S)	ADDITIONAL INFORMATION
2014	IS250, IS350	Body Type(s): 4Dr. Sedan

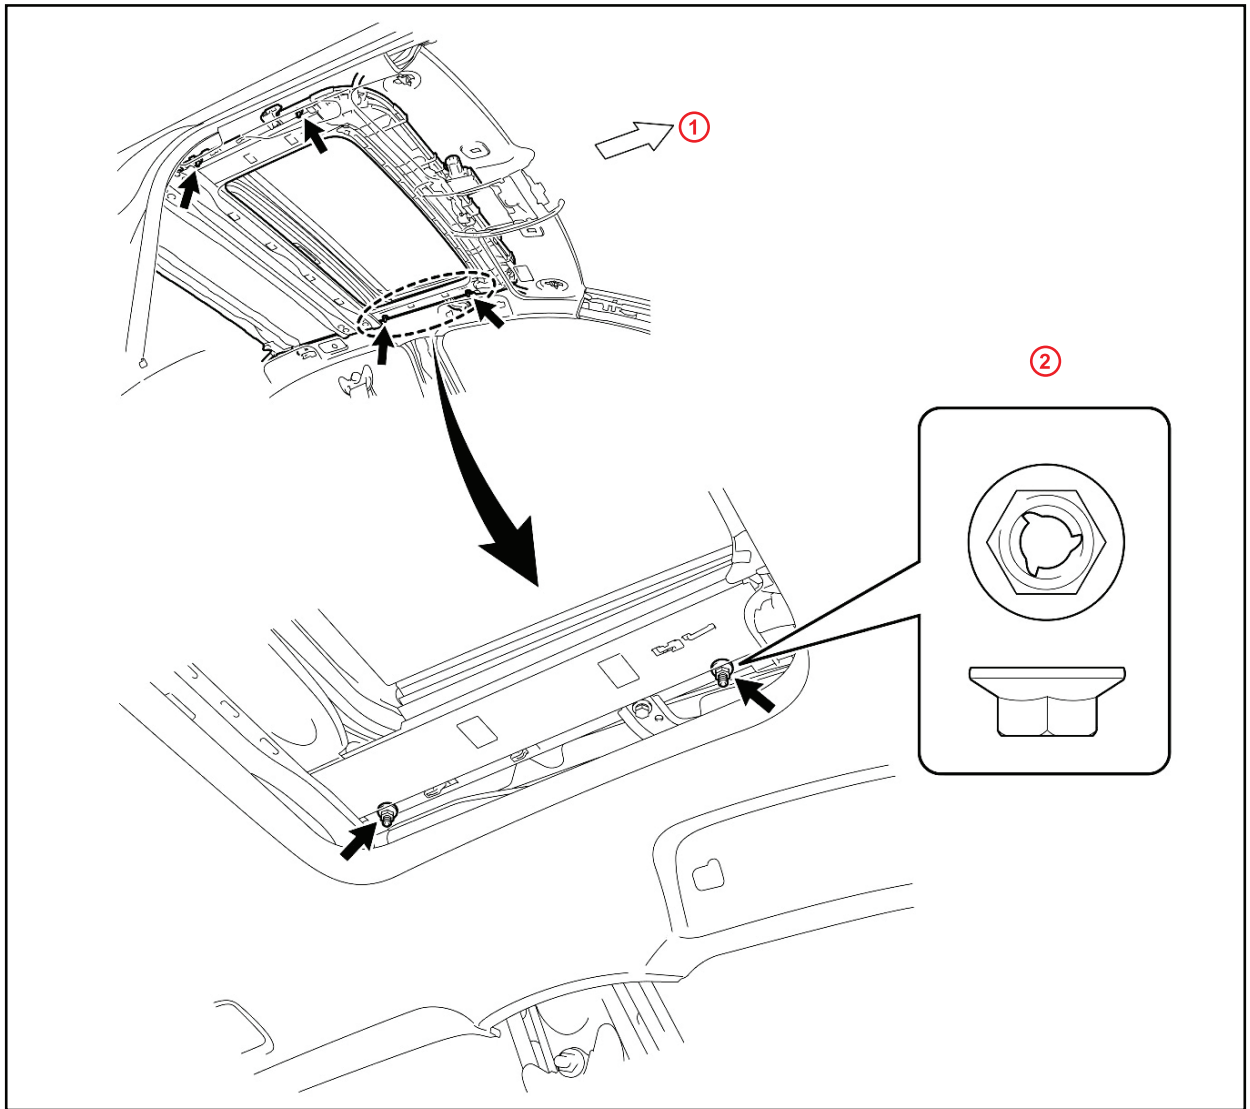
Figure 6.

1	Front
2	Sliding Roof Mounting Nut

7. Remove and discard the 4 sliding roof mounting nuts.

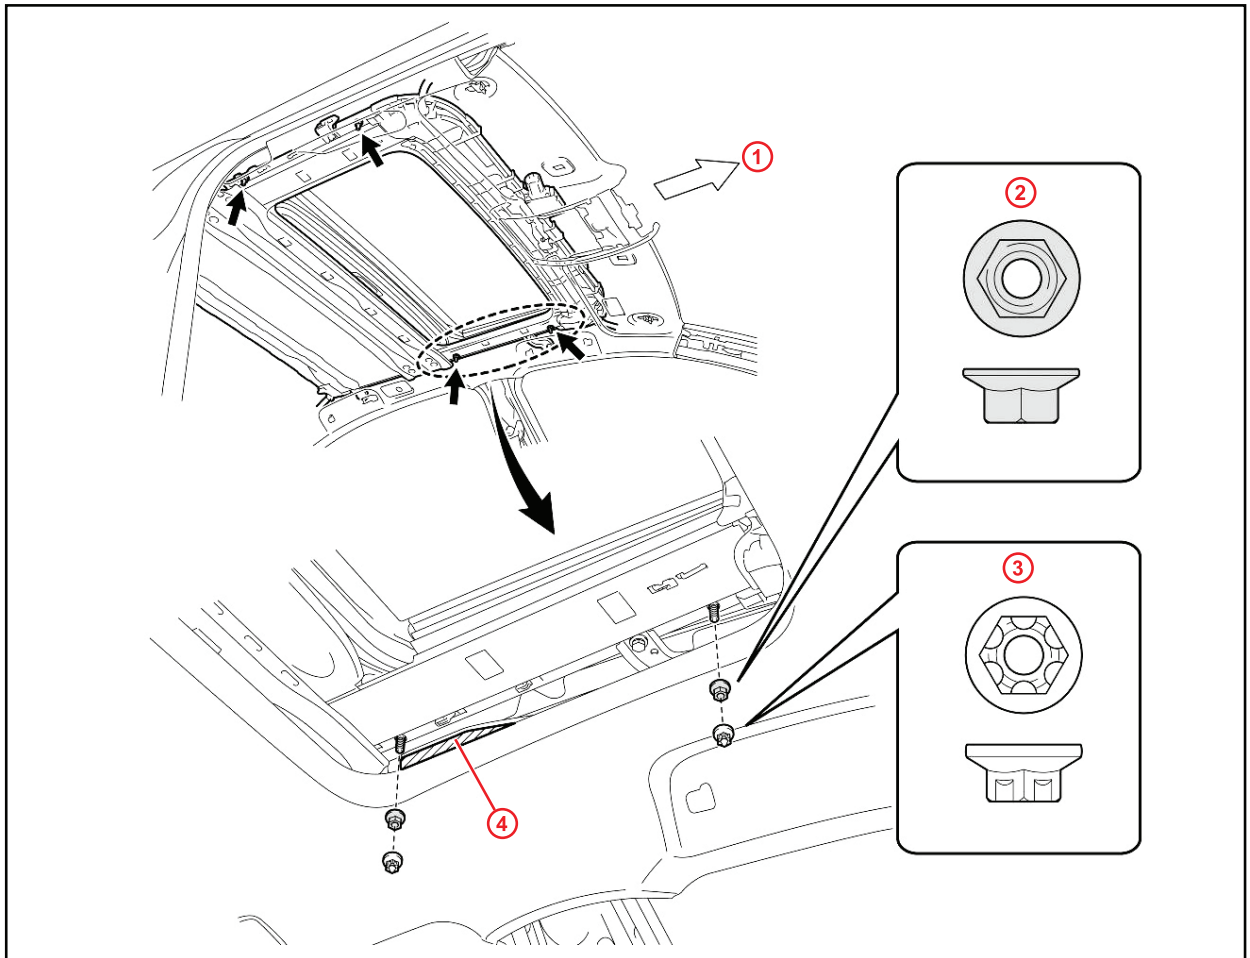
Figure 7.

1	Front
2	CZ Fastener Coating Nut (Black Nut, P/N 90179-06274)

3	Lock Nut (Silver, P/N 90177-06002)
4	Curtain Shield Airbag

1. Install the NEW sliding roof mounting nuts.
 - A. Tighten the 4 CZ Fastener Coating Nuts (Black Nut, P/N 90179-06274).

Torque: 7 N*m (71 kgf*cm, 62 in*lbf)

B. Tighten the 4 lock nuts (Silver, P/N 90177-06002).

Carefully tighten the nuts with the specified torque. If excessive torque is applied, the stud may break.

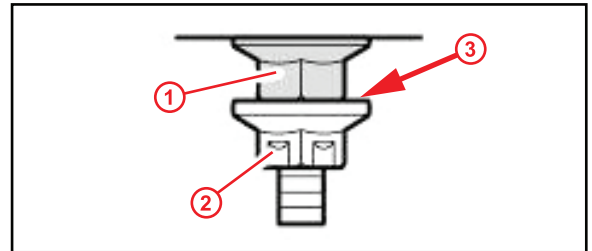
Figure 8.

1	CZ Fastener Coating Nut (Black Nut, P/N 90179-06274)
2	Lock Nut (Silver, P/N 90177-06002)
3	Even, Firm Contact Between Nut Surfaces

NOTE
Ensure that both nut surfaces are evenly and firmly in contact with each other.
