Ticking Noise from Rear Package Tray

Service Category Vehicle Exterior

Section Body Structure

YEAR(S)	MODEL(S)	ADDITIONAL INFORMATION
2013	FR-S	WMI(s): JF1

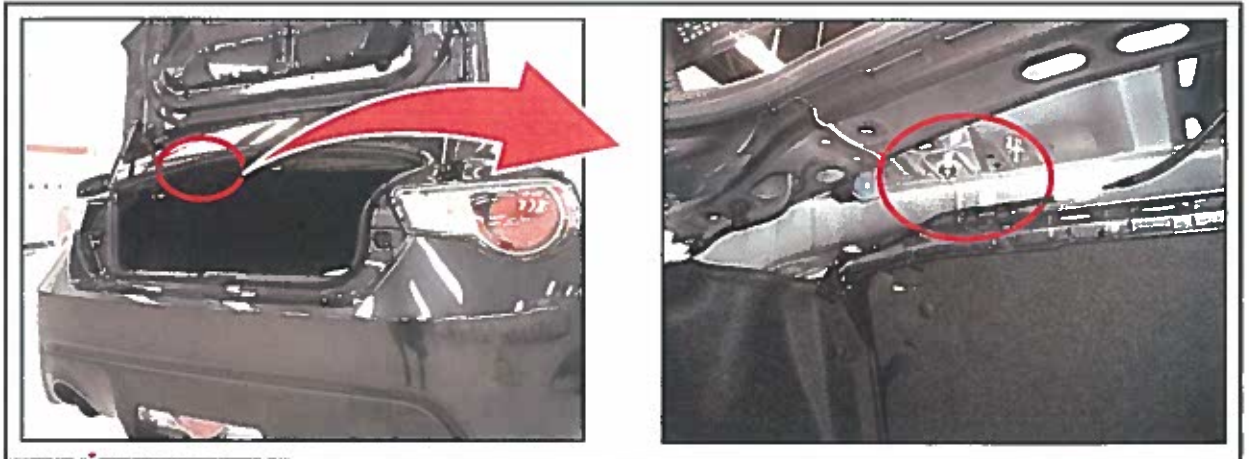
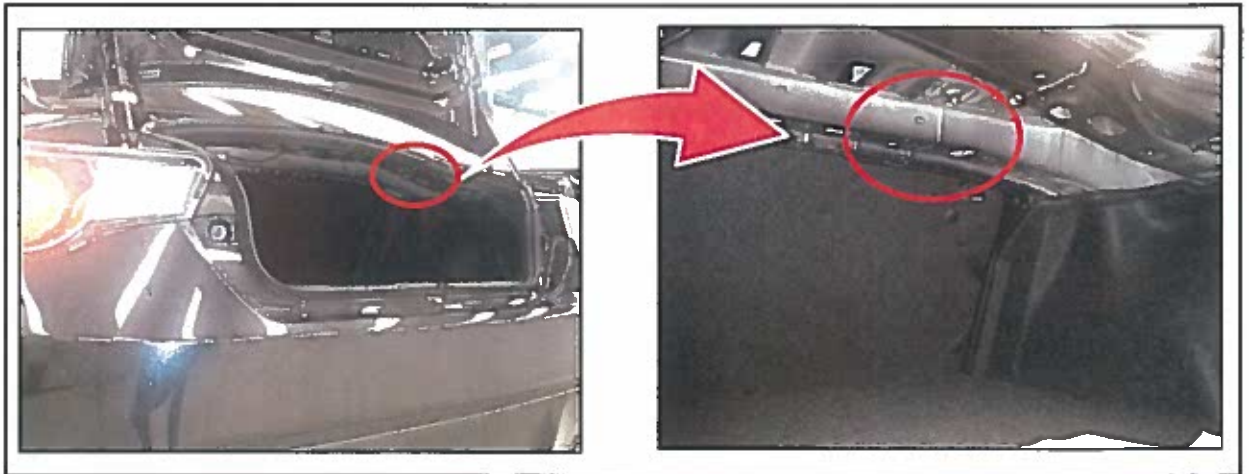
1. Test drive the vehicle to confirm that a noise is coming from the rear package tray area circled in Figures 2 and 3.

Figure 2. Driver Side

Figure 3. Passenger Side

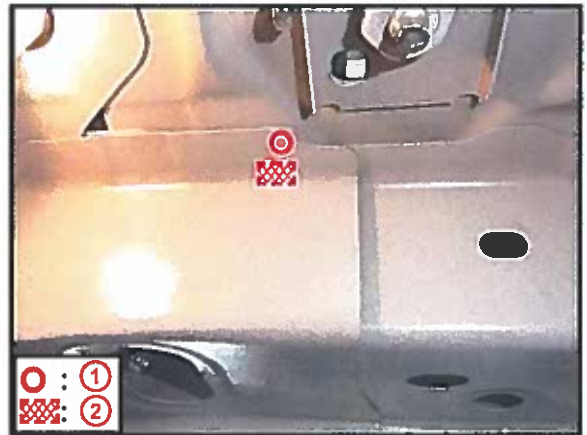
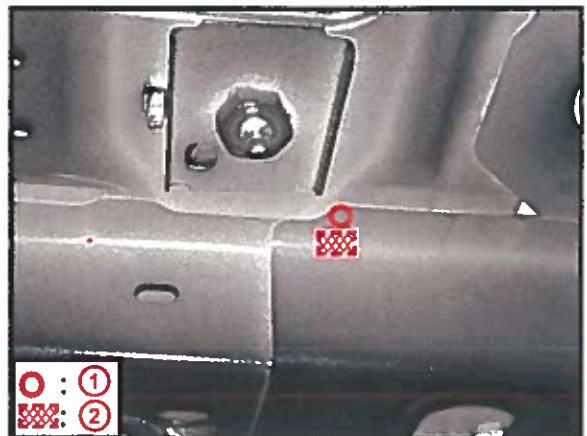
A. The noise source is located immediately adjacent to the vertical surface of the package tray as shown below. The adjustment area is located between the spot weld and vertical section.

Figure 4. Driver Side

Figure 5. Passenger Side

2. Adjust the gap between the lower and middle sheet metal panels as described below.

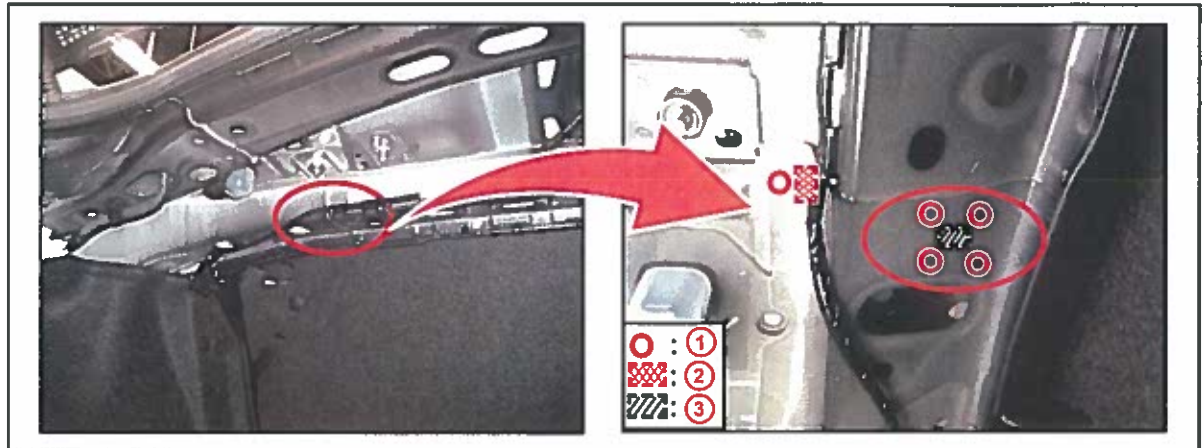
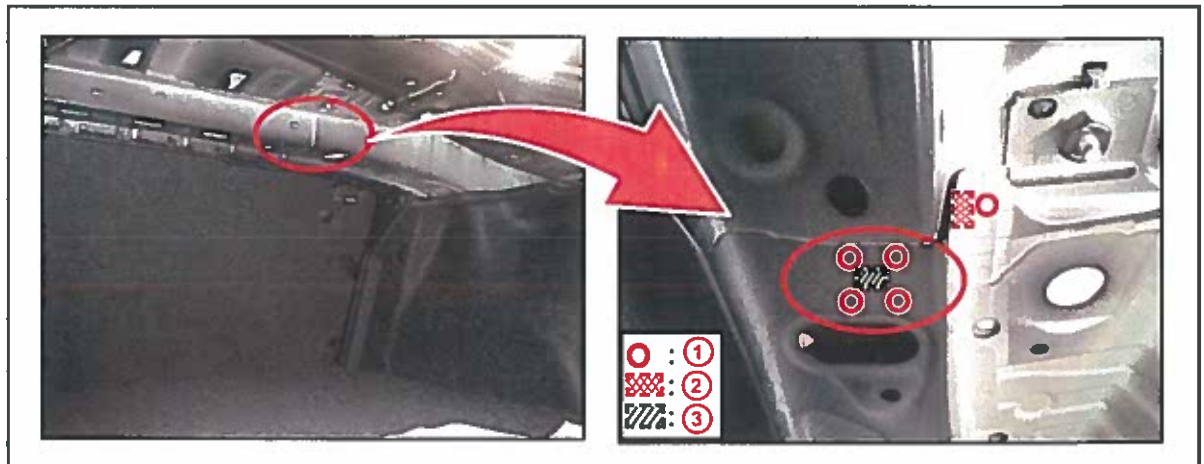
1. Confirm a noise is coming from the spot welded area shown in Figures 8 and 9. Noise source area is under the vertical section in Repair Procedure 1, shown in Figure 4.
 - A. Apply finger pressure to Adjustment Area B which is located between the 4 indicated spot welds to confirm that the noise is present.

Figure 8. Driver Side View From Under – Looking Up

Figure 9. Passenger Side View From Under – Looking Up

2. Adjust the gap between the lower and middle sheet metal panels.
 - A. Using the peen of the hammer, gently tap on Adjustment Area B (shown in Figures 8 and 9) by snapping the wrist with a 60 mm (approximately 2.36 in.) stroke.
 - B. Confirm the gap between the sheet metal sections has been reduced.
3. Test drive the vehicle and confirm that the noise is no longer present from the areas identified in Repair Procedure 1 or 2.

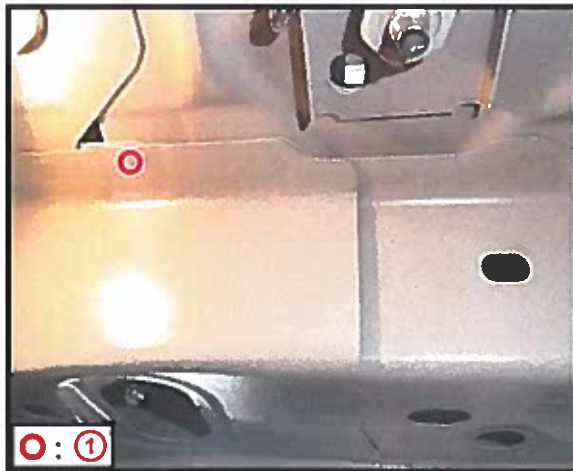
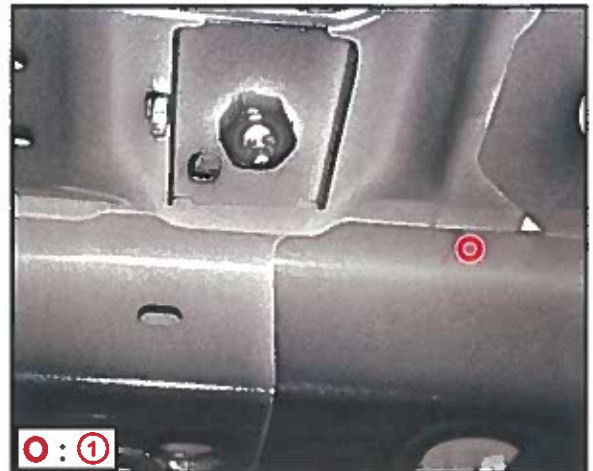
1. Confirm that the noise is coming from the rear package tray area as indicated below.

Figure 10. Driver Side View

Figure 11. Passenger Side View

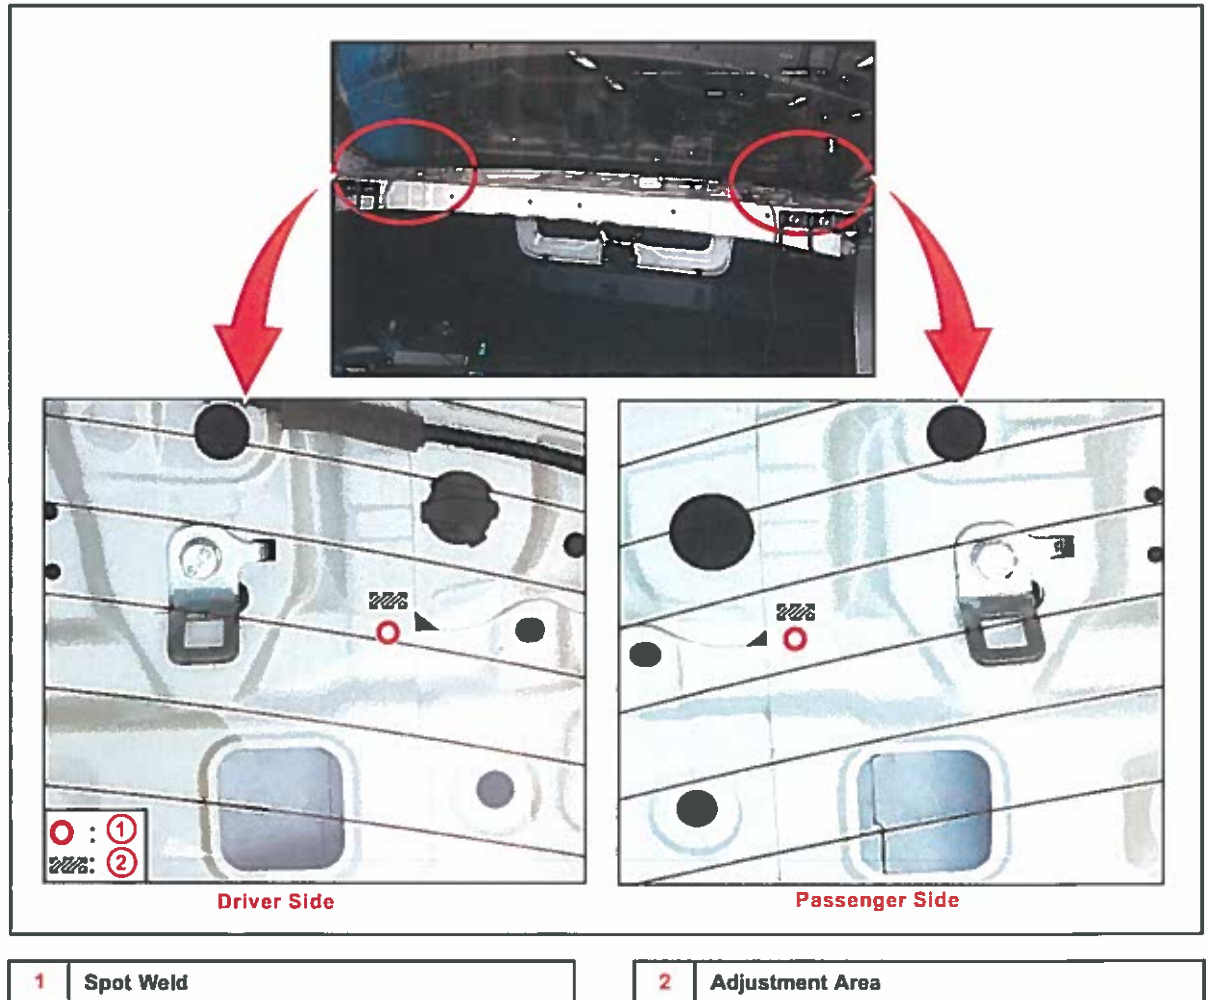
A. The area of concern is serviceable from the top of the rear package tray sheet metal. See Figure 12 for adjustment area.

Figure 12. View From Inside of Vehicle Without Package Tray

- B. From the inside of the vehicle, use a 5 mm Hex wrench (or equivalent) and the side face of a hammer to tap on the adjustment section as shown in Figure 11, 12 and in the video.

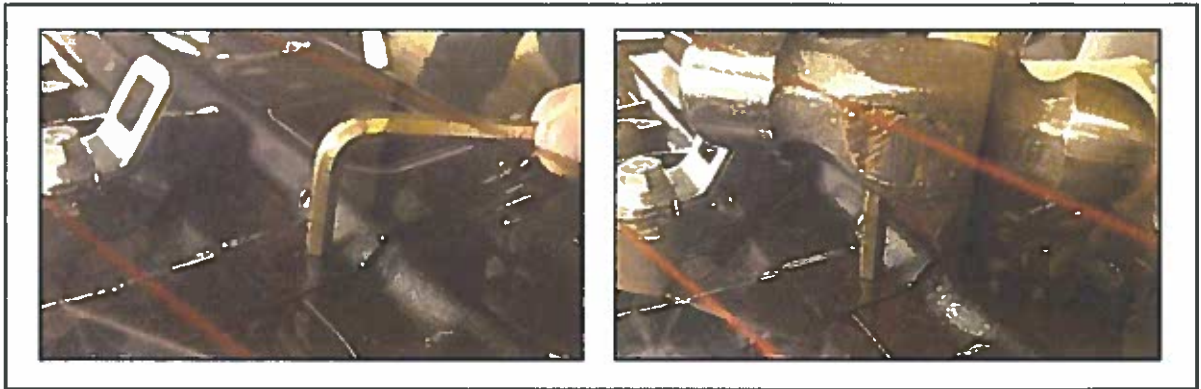
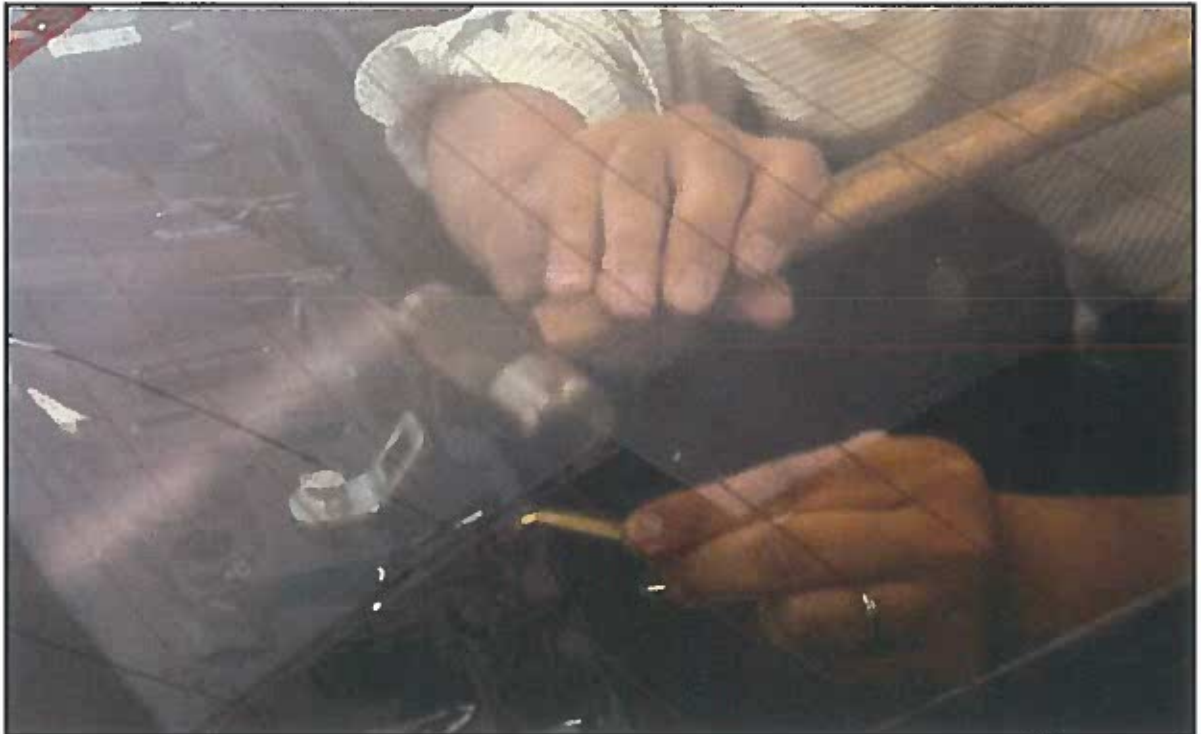
Figure 13. Close-up of Adjustment Point

Figure 14. Adjustment Shown on Passenger Side
