# Integration Relay - Poor Ground

YEAR(S)	MODEL(S)	ADDITIONAL INFORMATION
2012 – 2013	Camry HV	
2012 – 2013	Camry

Some 2012 – 2013 model year Camry and Camry HV vehicles may exhibit a condition where the passenger-side headlight and rear defogger operate continuously.

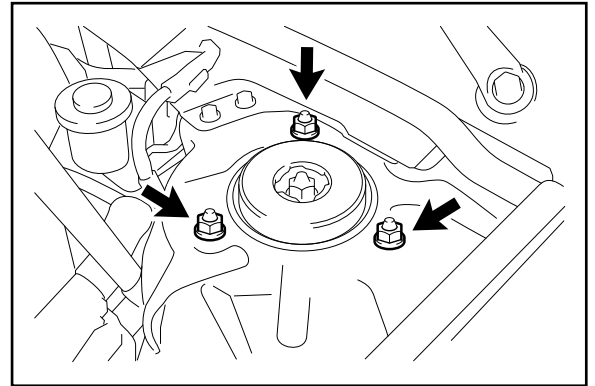
Figure 4.

- A. Use a left front strut tower mounting bolt as a good body ground (see Figure 4).
- B. To perform voltage drop test, connect the negative lead of the DVOM to the strut tower bolt, and the positive lead to the ground wire eyelet tab.
