Power Back Door Does Not Close Properly

Service
 Category Vehicle Exterior

Section Door/Hatch

YEAR(S)	MODEL(S)	ADDITIONAL INFORMATION
2008 – 2012	Highlander, Highlander HV	WMI(s): 5TD, JTE

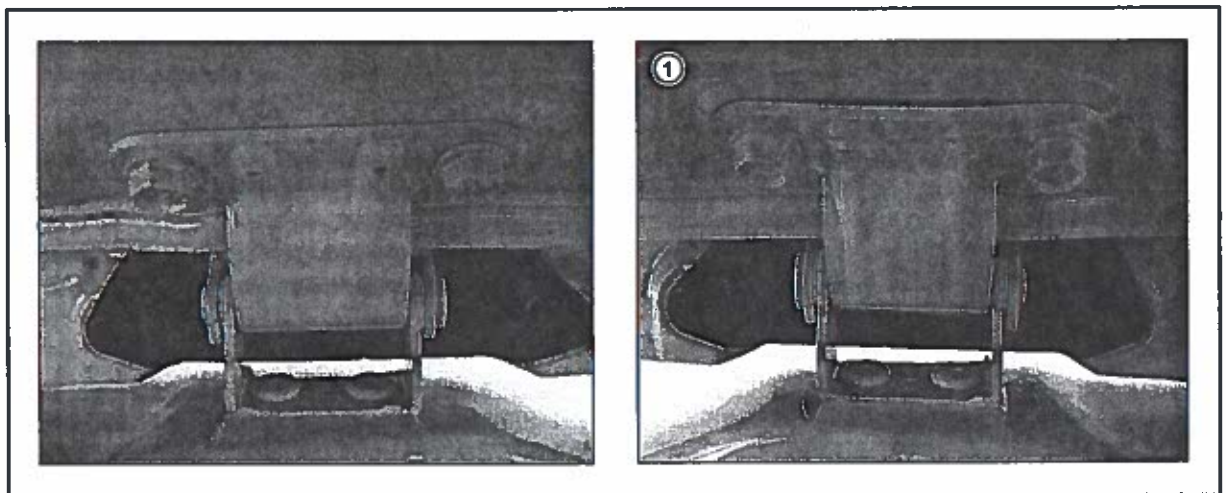
1. Inspect the upper hinges for any gaps present by placing a 0.05 mm (0.002 in.) or greater feeler gauge between the 2 bolts mounted to the back door as shown in Figure 1. If a gap exists, replacement of both Back Door Hinges AND the Back Door Panel Sub-assembly is required. Proceed to step 2.

1	Gap Location
---	--------------

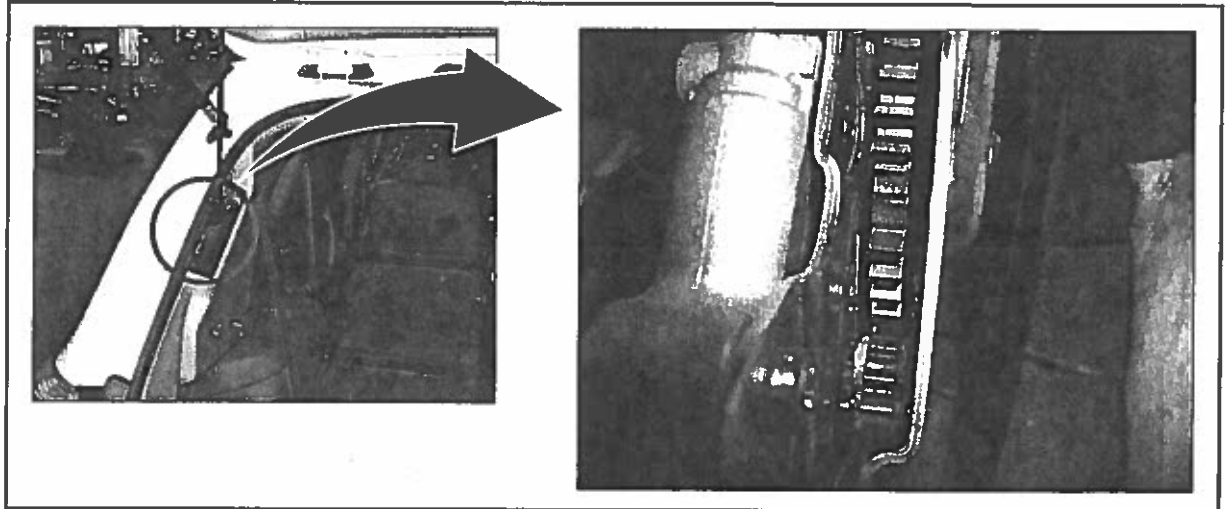
2. Visually inspect the back door motor teeth for damage by opening the back door and manually moving the door towards the half-closed position while observing the large gear teeth for damage, as shown in Figure 2. If damage is found, replacement of the Back Door Motor Unit is required.

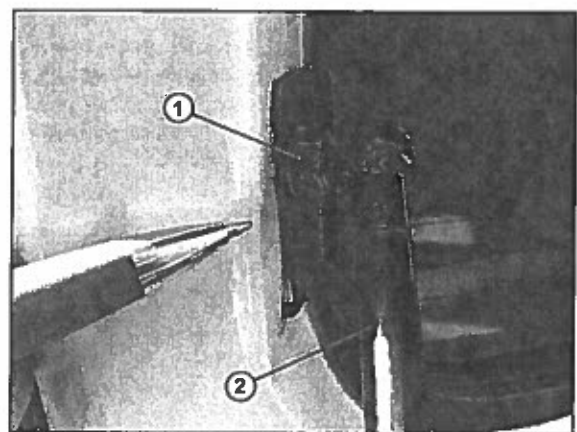
Figure 3.

3. Visually inspect the Back Door Upper Rod and Lift Arm Stud for bends or damage. If it is bent, or damage is found, replacement is required.

1	Lift Arm Stud
2	Back Door Upper Rod

The Back Door Upper Rod and Lift Arm Stud are available as separate service parts from the Back Door Motor Unit if found damaged or bent.

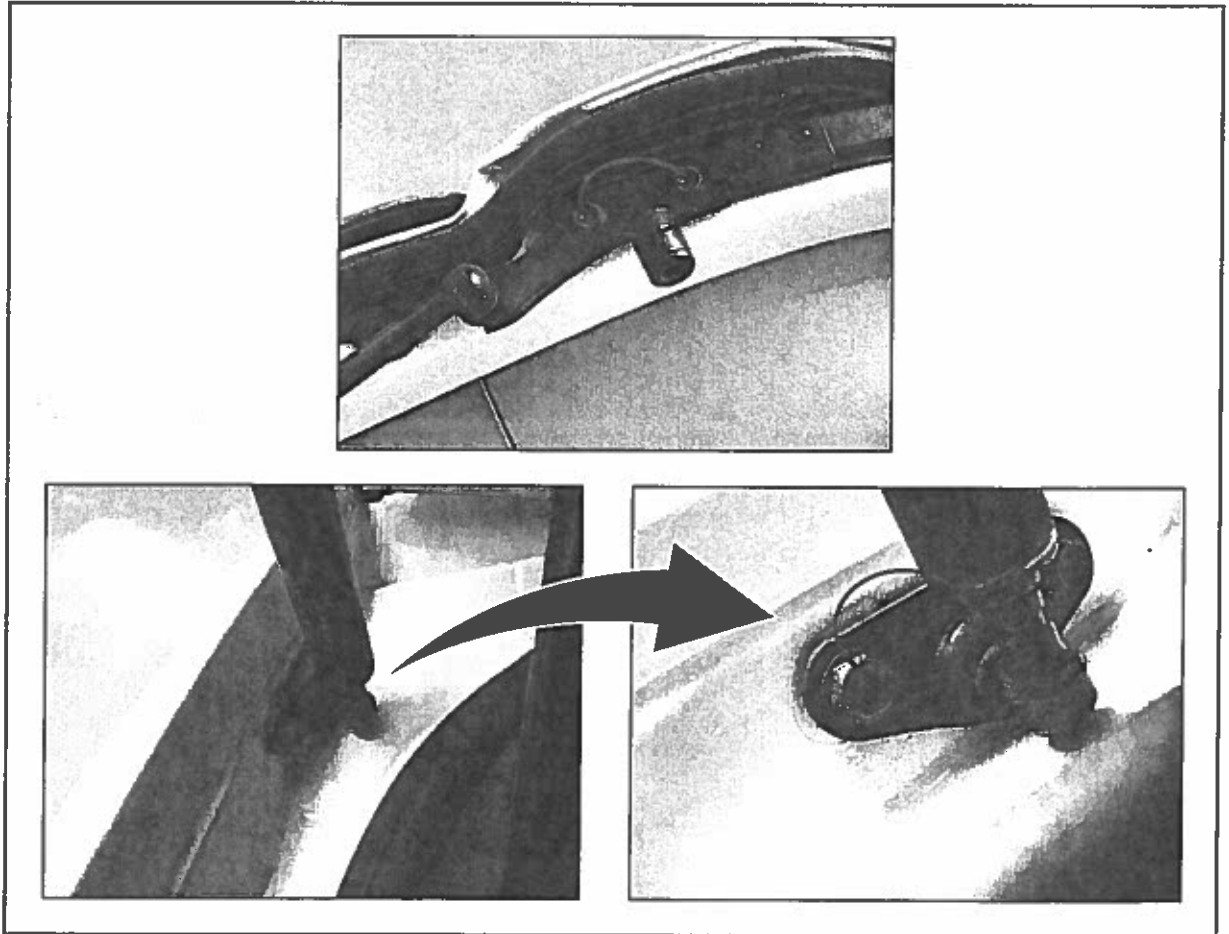
Figure 4.

To ensure correct installation of the back door struts, note the markings on the assembly (Figure 4). The markings indicate on which side of the car the strut should be installed, and the direction of the braces on the strut.
