# MIL "ON" DTC P0A80 or P0A7F due to Dust or Debris in HV Battery Cooling Fan

YEAR(S)	MODEL(S)	ADDITIONAL INFORMATION
2012	Camry HV

Some 2012 model year Camry HV vehicles may exhibit a MIL "ON" condition with Diagnostic Trouble Code (DTC) P0A80 or P0A7F stored due to dust or debris build-up in the HV Battery Cooling Fan. Use the following repair procedure to address this condition.

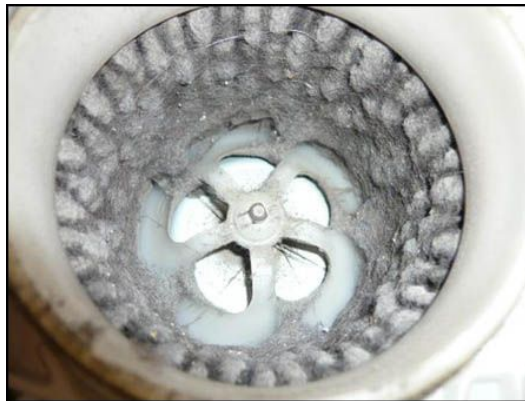
Figure 1.

Is the HV Battery Cooling Fan clogged with dust or debris build-up? Refer to Figure 1 for an example of a clogged cooling fan.

2. Clean dust and debris build-up from the HV Battery Cooling Fan with compressed air or vacuum.

3. Replace the HV Battery Assembly.
