Flex Fuel Extended Crank due to Alcohol Density Calculation

Service
Category Engine/Hybrid System

Section Engine Control

YEAR(S)	MODEL(S)	ADDITIONAL INFORMATION
2012 – 2013	Sequoia	
2012 – 2013	Tundra

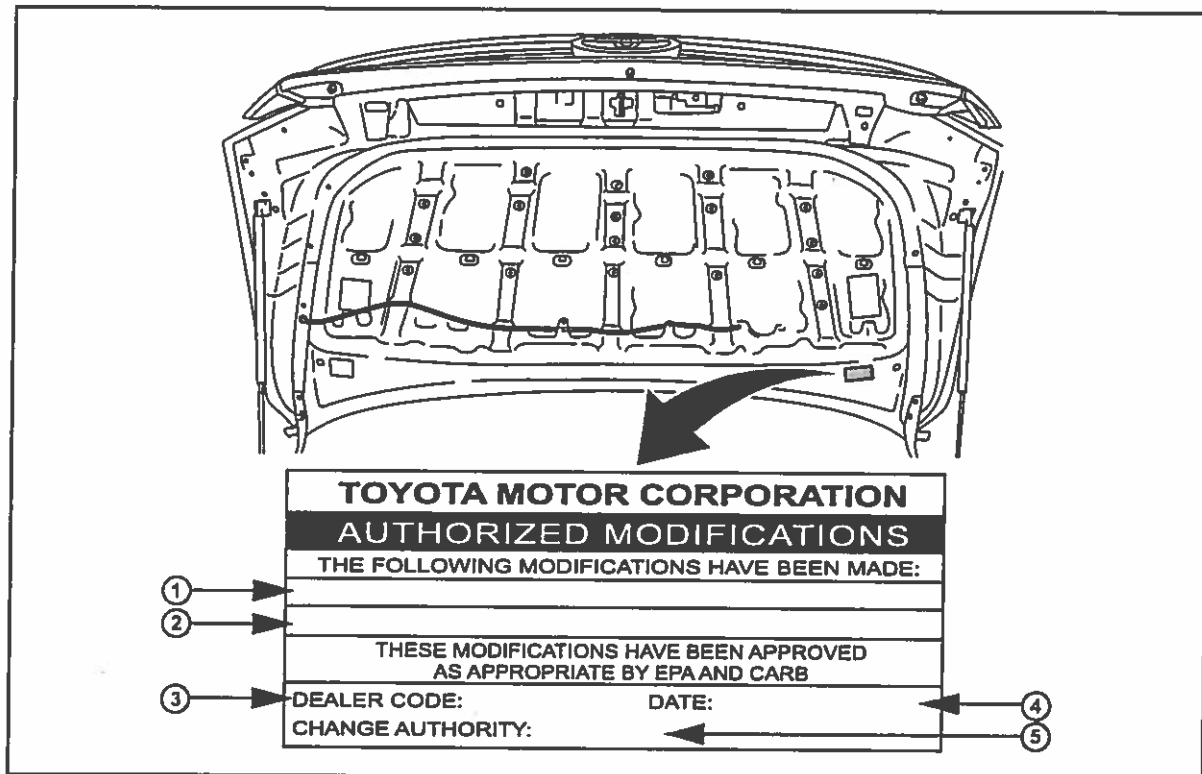
Figure 1. Location of Authorized Modifications Label on 2012 – 2013 Sequoia and Tundra

4. Check for the Authorized Modifications Label affixed to the vehicle in the location shown in Figure 1. Confirm if the ECM (PCM) calibration has been updated. If the calibration ID listed is NOT the latest ECM (PCM) calibration — go to step 5.

B. Affix the Authorized Modifications Label to the vehicle at the location shown in Figure 1. The Authorized Modifications Label is available through the MDC, P/N 00451-00001-LBL.
