Excess Water Accumulation in Rear Spoiler

Service Category Vehicle Exterior

Section Exterior Panels/Trim

YEAR(S)	MODEL(S)	ADDITIONAL INFORMATION
2013	tC

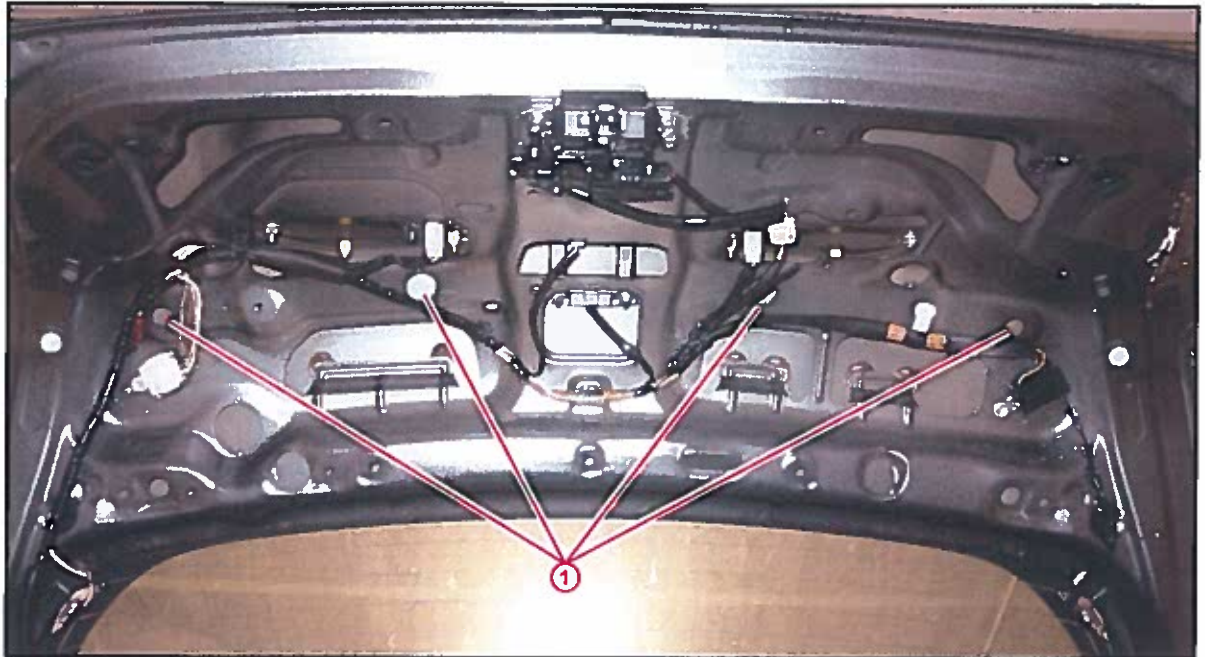
Figure 5.

1	Access Holes
----------	---------------------

2. Remove the spoiler.
 - A. With the lift gate open, loosen and remove the 4 nuts on the studs. Utilize the 4 access holes in the inner panel for the removal of these nuts.

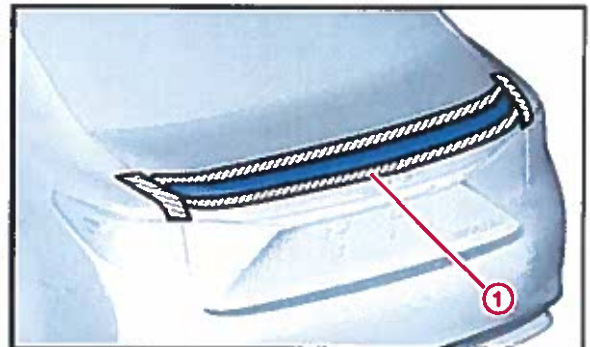
Figure 6.

1	Protective Tape
----------	------------------------

If it is necessary to pry against the tailgate to remove the spoiler, apply protective tape around the rear spoiler as shown.
