Passenger Side Floor Mat Bunching

Service Category Vehicle Interior

YEAR(S)	MODEL(S)	ADDITIONAL INFORMATION
2013	LS460	VDS(s): BL1EF, BL5EF, GL1EF, GL5EF

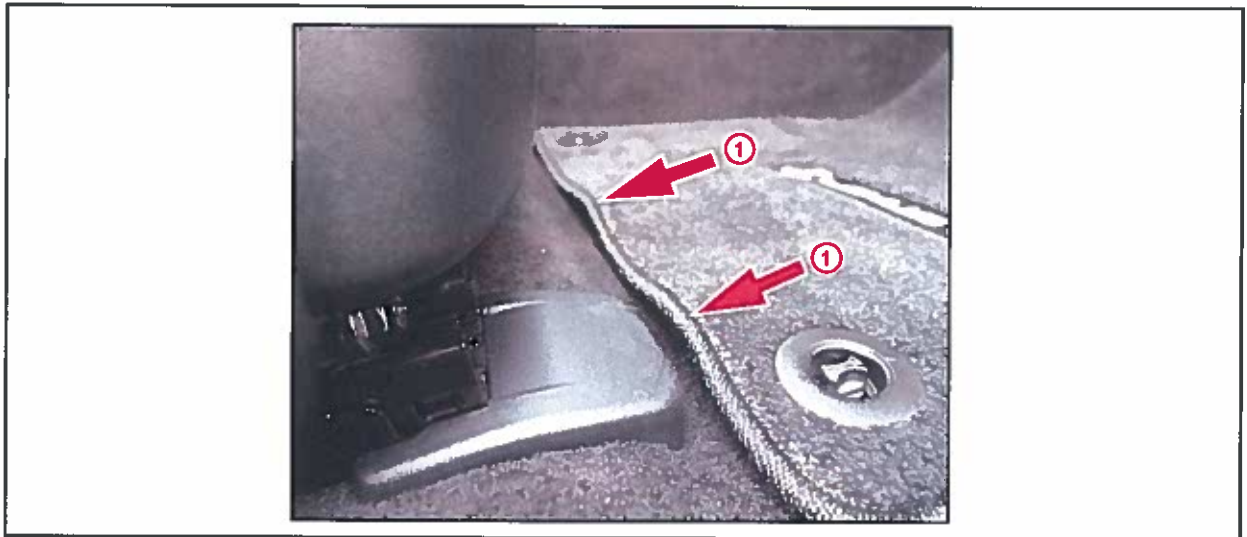
Figure 1.

Is the floor mat bunching?

1	Bunching Present
----------	-------------------------

- **YES** – Proceed to step 2.

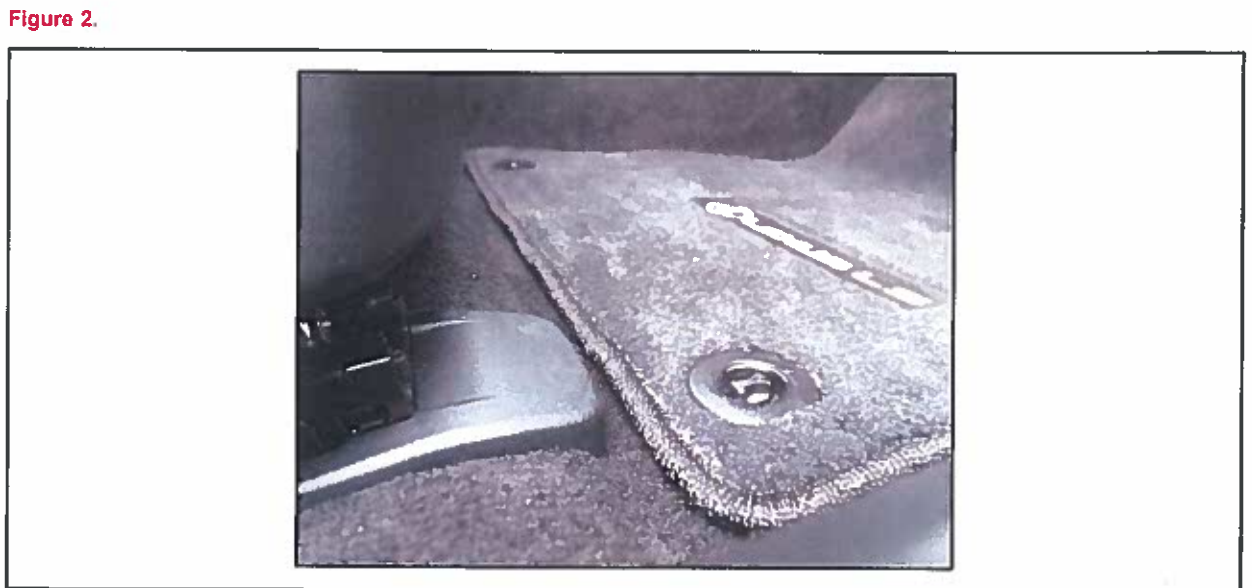
- **NO** – The vehicle has the correct floor mat. Return vehicle to the customer.

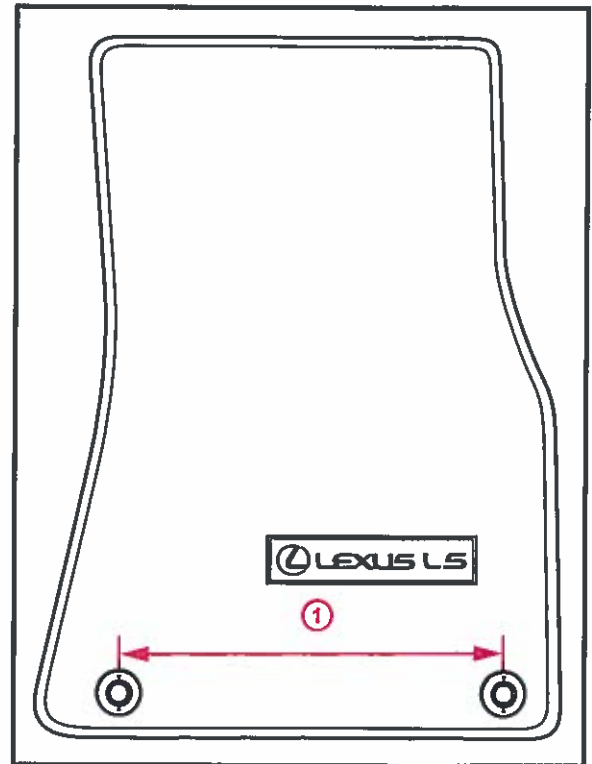
Figure 3.

2. Remove the floor mat and measure the distance between the 2 grommets as shown.

1 Distance Between Grommets

3. Confirm that the distance between the center points of the grommets is within the acceptable range.

Acceptable Range: 393 – 397 mm (15.47 – 15.63 in.)

- **YES** – Reinstall the original floor mats.
- **NO** – Replace the floor mat with the new service parts.

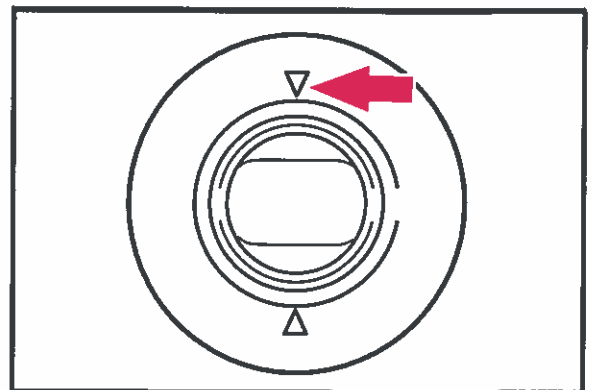
Be sure to measure between the reference arrows as shown in Figure 4.
