# Service Bulletin

## PRELIMINARY INFORMATION

**Subject:** Exhaust Leak and/or Service Vehicle Soon (SVS) On and DTC P0171 Set

**Models:** 2013 Chevrolet Cruze, Sonic  
2013 Chevrolet Trax (Canada Only)  
Equipped with 1.4L Engine (RPO LUV)

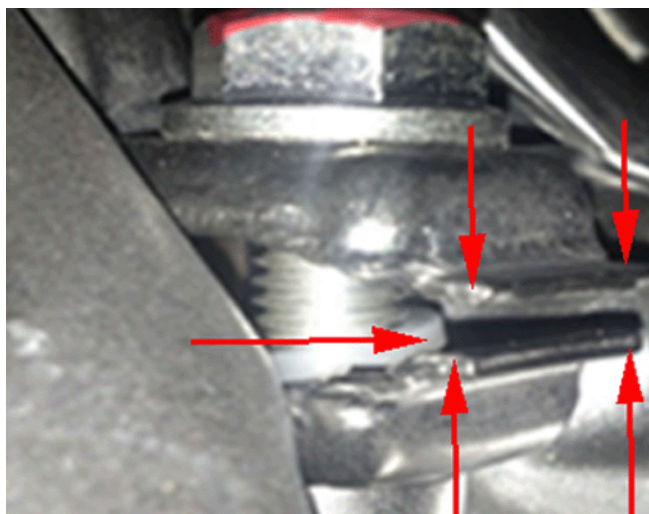
This condition may be caused by excessive amount of glue used by the supplier to retain the gasket before mounting the converter to the manifold. Hardened glue may have filled the sealing gap, which restricts the V-band clamp to draw both flanges together completely.

**Note:** The illustration above shows the ends of the V-band clamp with the gap.

2. Unscrew the fastener on the V-band clamp a total of several rotations.
3. Using a screwdriver, pry the clamp apart and make sure that both halves of the clamp are loose and not stuck to either flange.
4. Tighten the bolt.

**Tighten:** Tighten the bolt to 13 Y (115 lb in).

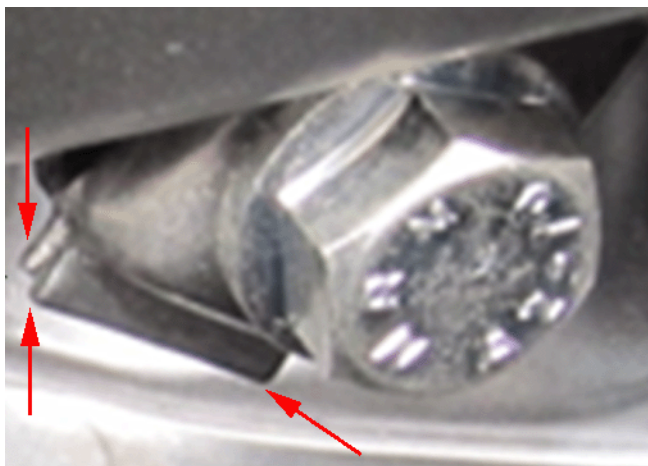
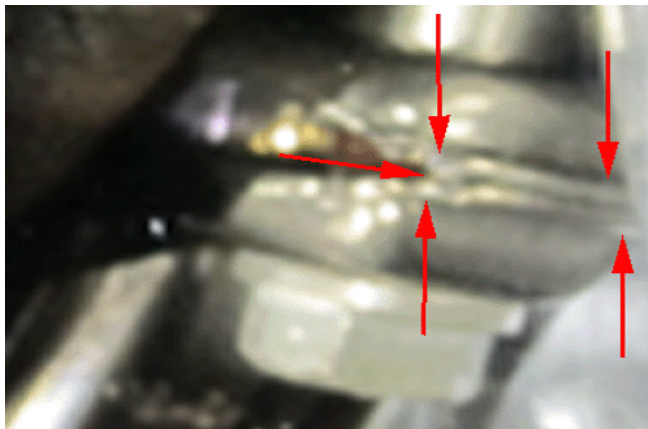
**Note:** The illustrations above show the ends of the V-band clamp with both flanges together completely.
