Service Bulletin

PRELIMINARY INFORMATION

Subject: Rear and Side Tempered Glass Spots (Quench Marks)

Models: 2014 and Prior GM Passenger Cars and Trucks

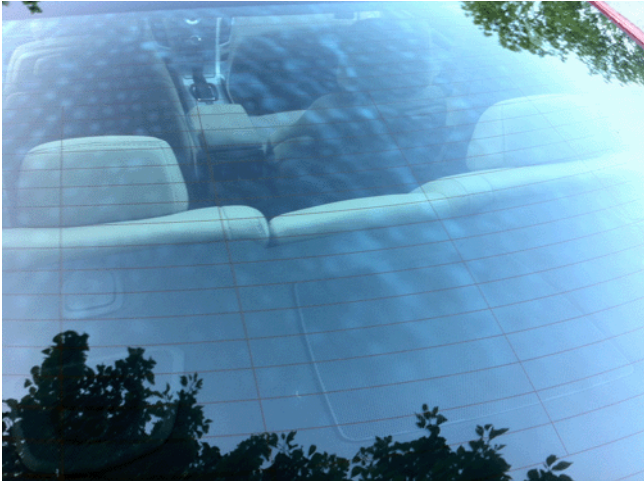
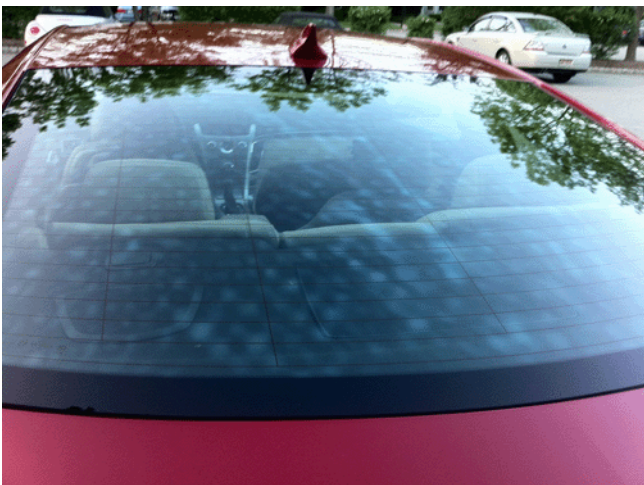
Some customers may comment on spots showing on the rear and side windows when the vehicle is in the sunlight. When wearing polarized glasses/sunglasses, these spots may be more magnified.

The spots are due to the manufacturing process and are “quench marks” in the glass. Quench marks are an unintentional side effect of the tempering process.

Technicians should explain to the customer that this is a normal condition and part of the manufacturing process for tempered glass. Do not replace the

window(s) for this condition.
