Service Bulletin

Subject: Engine Oil Consumption on Aluminum Block/Iron Block Engines with Active Fuel Management (AFM)
(Install AFM Oil Deflector and Clean Carbon from Cylinder and/or Install Updated Valve Cover)

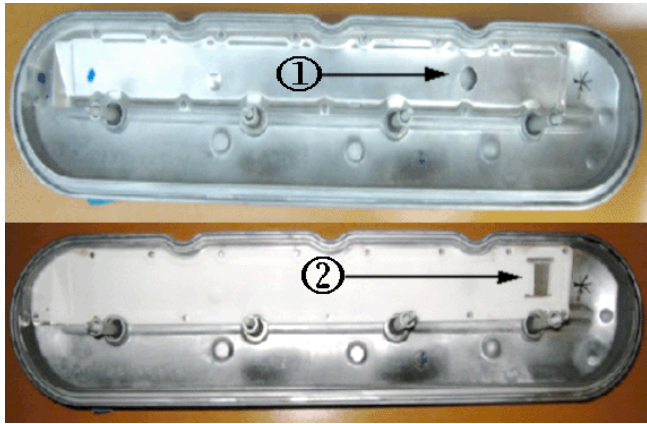
1) Old Design

2) New Design

PCV pullover or an overactive lifter can cause oil to be pulled through the PCV system even at low vehicle mileage. A correctly functioning PCV system will only leave a film of oil in the intake manifold. Inspect the intake manifold to see if there is any oil puddling in the bottom. If there is you will need to replace the left valve cover. Two new left rocker arm covers have been released for trucks and vans. Technicians should replace the left rocker arm cover with GM P/N 12570427 for 2007-2008 or GM P/N 12642655 for 2009-2011. Refer to the Parts Information below for the Camaro. This rocker arm cover has a relocated PCV drain hole that prevents oil from entering the intake manifold. Refer to Valve Rocker Arm Cover Replacement - Left Side in SI.

Note: These rocker covers are for specific years. The PCV orifice is different for each. The correct cover must be used or an SES light may set.
