Service Bulletin

PRELIMINARY INFORMATION

Subject: SERVICE HIGH VOLTAGE CHARGING SYSTEM Message Displayed on Driver Information Center (DIC), Hybrid/EV Charging System Disabled, DTCs Set, Revised HV Battery Surge Tank Coolant Fill Level

Models: 2011-2014 Chevrolet Volt

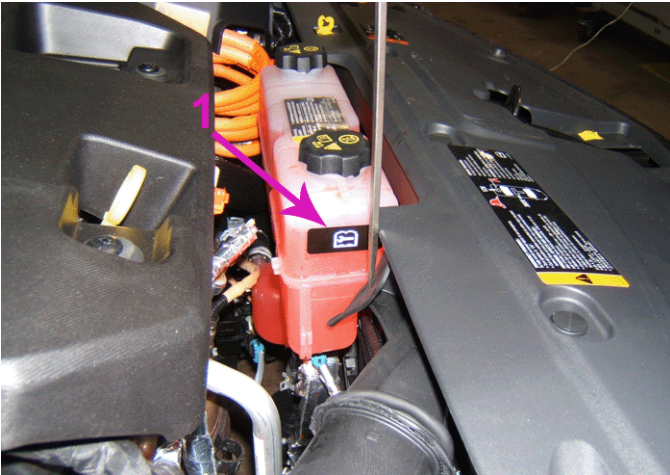
5. Visually inspect the coolant level in the HV battery surge tank and verify that the coolant level is **at the top of the label (1)** on the side of the surge tank.

⇒ If the HV battery surge tank coolant level is **not at the top of the label (1)** on the side of the surge tank, Go to the section titled: **Pressure Test Procedure** in this Diagnostic.

⇒ If the HV battery surge tank coolant level is **at the top of the label (1)** on the side of the surge tank, Go to Step 6.

13. Upon completion of the Hybrid/EV battery pack coolant pump bleed procedure, **adjust** the surge tank coolant level to the **top of the label (1)**, by performing this procedure, — Drive Motor Battery Cooling System Draining and Filling — Removing Excess Coolant From System in SI.
