Bulletin No.: PI1142

# Service Bulletin

**Subject:** Front Floor Console Extension Side Panel Change

**Models:** 2014 Chevrolet Impala  
Vehicles Built Prior to November 1, 2013

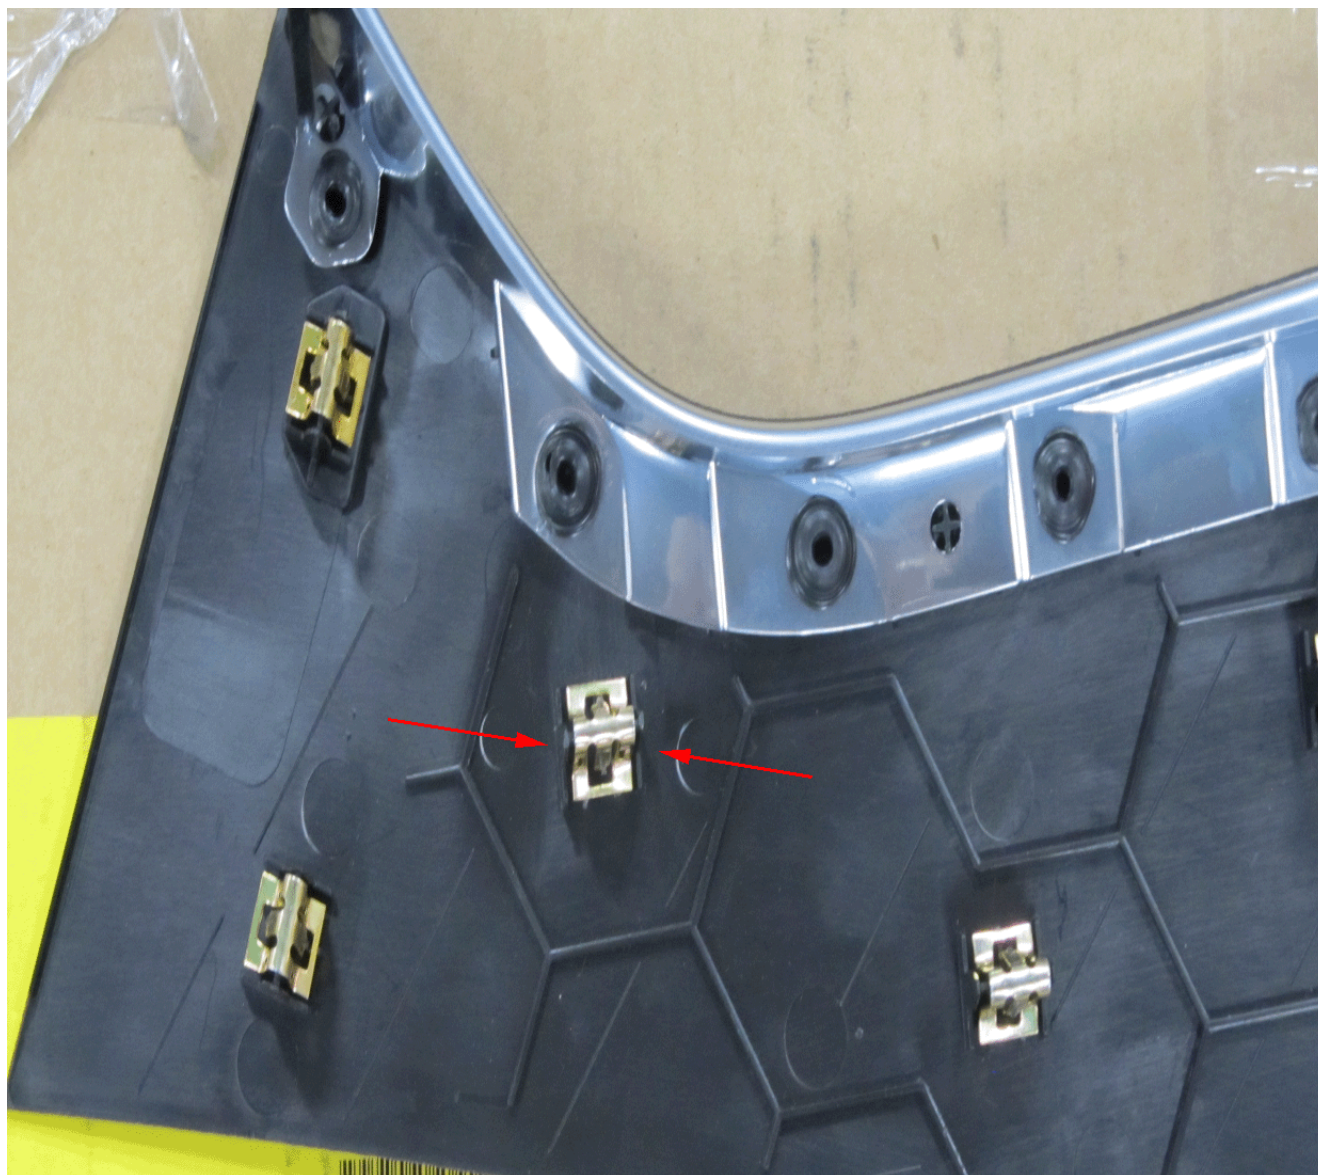
The purpose of this PI is to inform the technician that when replacing the front floor console extension side panels, the new panels come with an additional clip tower, shown in the illustration above, that needs to be modified for vehicles built prior to the date listed above.
