Service Bulletin

Subject: Information on Body Mount Bolt Stripped or Will Not Loosen

Models: 2010-2013 Chevrolet Silverado
2010-2013 GMC Sierra

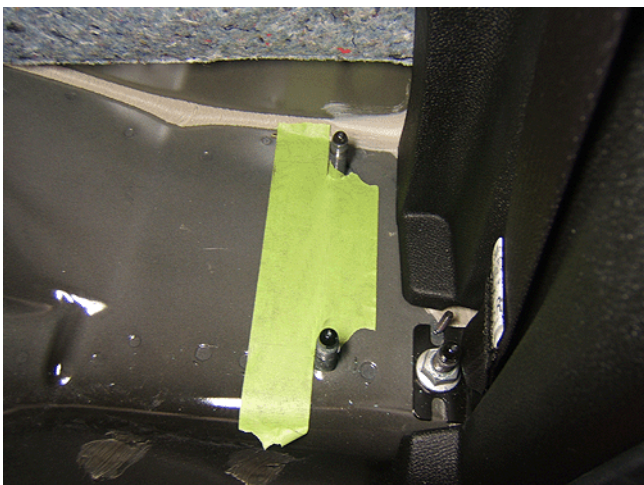
3. Apply masking tape to the repair area as shown.

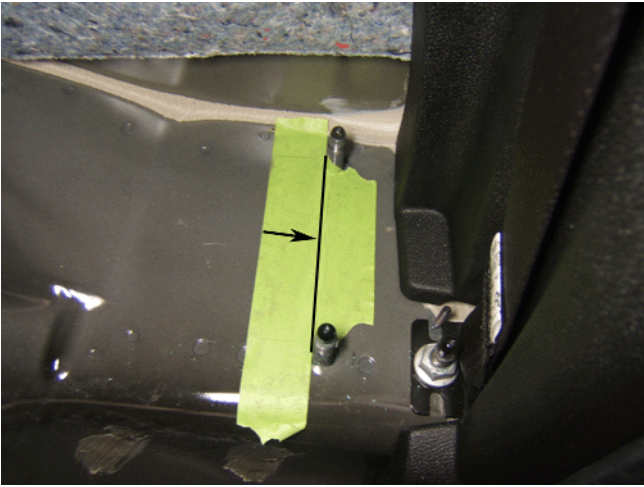
4. Using a straight edge, create a line along the inboard side of the seat mounting studs as shown.

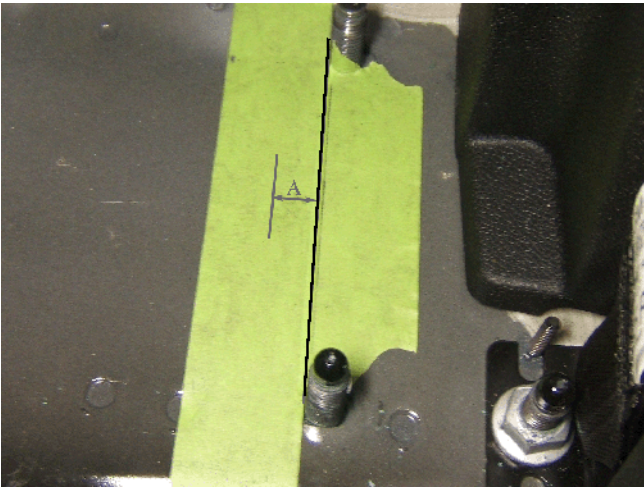
5. Measure and mark as shown (A), 10 mm (3/8 in).

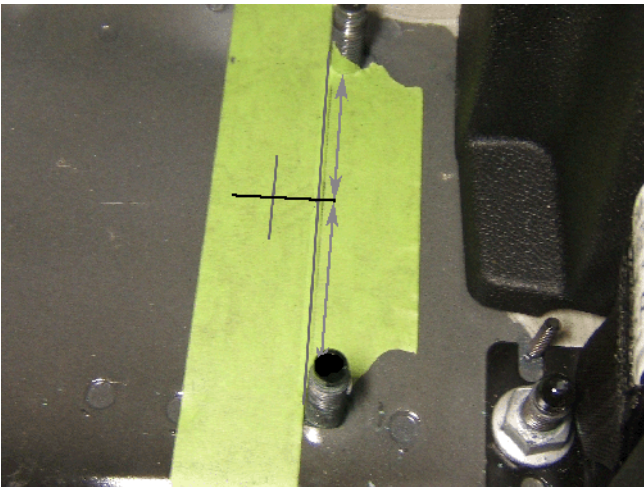
6. Find the center point between the two mounting studs as shown. Create a second mark as shown.
7. Use a center punch to create a mark in the sheet metal.

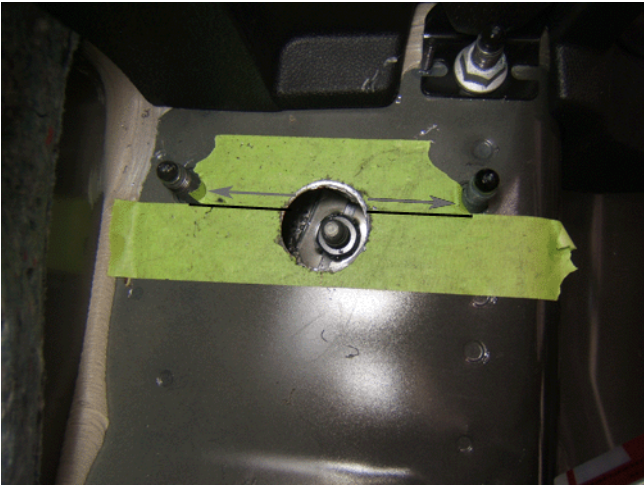
8. Using a 1-1/2 in. hole saw, create an access hole as shown.
9. Service the cab mounting bolt and nut as required.

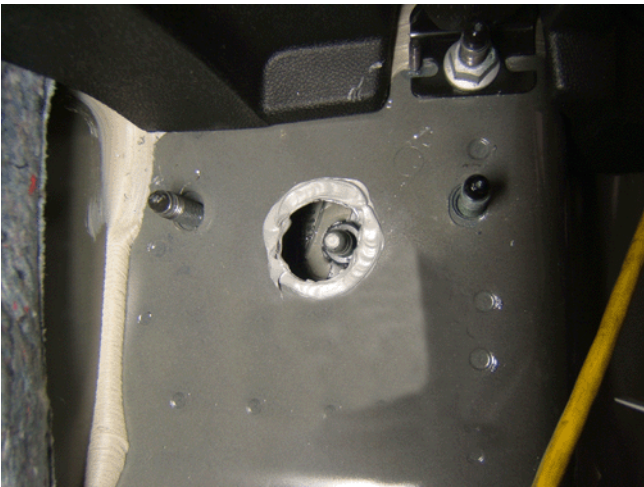
10. Coat the perimeter of the access hole with RTV Silicone Sealant, GM P/N 12378521 (in Canada, 88901148) or equivalent, to seal the bare edge of the metal.

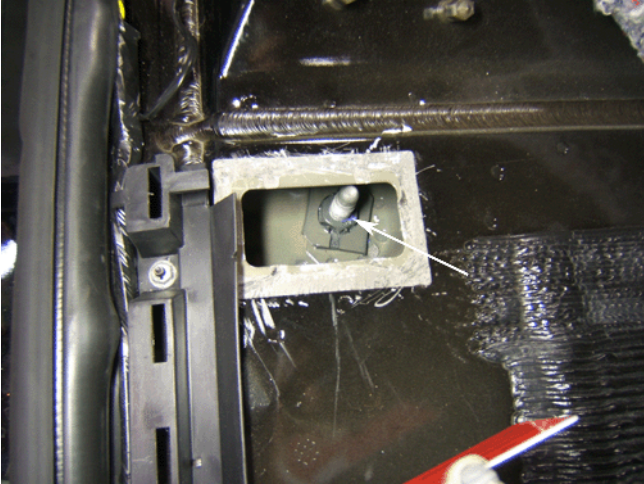
2. Remove the sill trim plate. Refer to Front Side Door Sill Trim Plate Replacement in SI.
3. Partially remove (pull back) the floor covering (carpet) to expose the rectangular service plug.
4. Using a gasket scraper or similar tool, pry off and discard the rectangular floor plug.

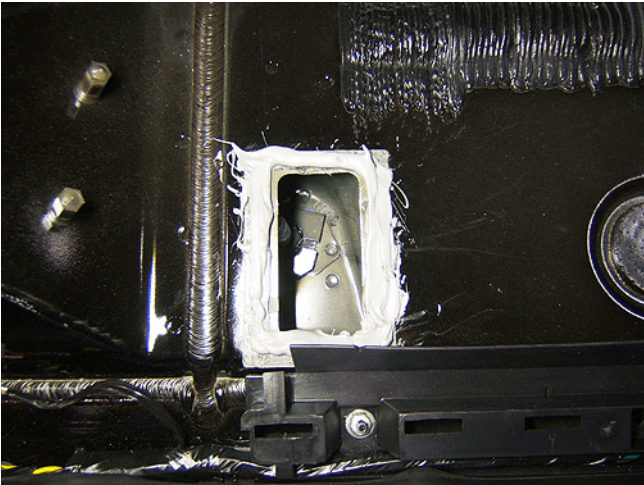
5. Service the cab mounting bolt and nut as required.

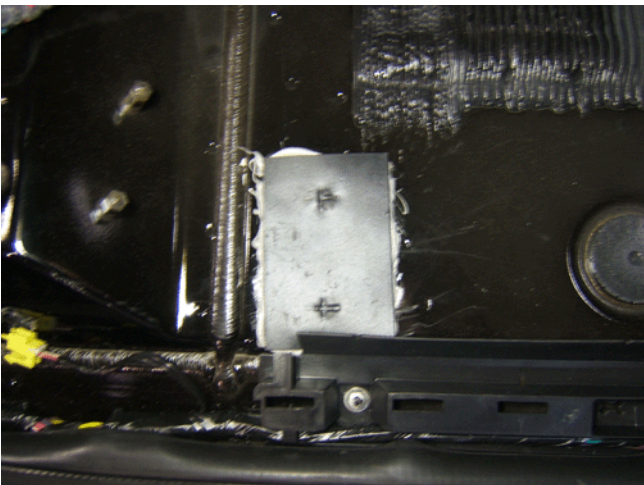
6. Coat the perimeter of the access hole with RTV Silicone Sealant, GM P/N 12378521 (in Canada, 88901148) or equivalent, to seal the bare edge of the metal.

7. Install the rectangular body plug, GM P/N 15040085. Ensure that the plug is sealed with the silicone sealant.
8. Reinstall the floor covering, sill trim and seat.
