# Service Bulletin

**Subject:** Engine Oil Consumption on Aluminum Block/Iron Block Engines with Active Fuel Management (AFM)  
(Install AFM Oil Deflector and Clean Carbon from Cylinder and/or Install Updated Valve Cover)

**Models:** 2007-2011 Cadillac Escalade Models  
2007-2011 Chevrolet Avalanche, Silverado 1500, Suburban, Tahoe  
2010-2011 Chevrolet Camaro  
2007-2011 GMC Sierra 1500, Sierra Denali, Yukon Models  
2008-2009 Pontiac G8 GT  
Built Prior to February 1, 2011 (Updated Valve Cover) and October 2010 (AFM Shield)  
Equipped with Any of the Following Engines:  
– Aluminum Block V8 Engine with Active Fuel Management (AFM) (RPOs L94, LZ1, L99, LC9, LH6, L76, L92, LFA (Hybrid))  
– Iron Block V8 Engine with Active Fuel Management (AFM) (RPOs LMG, LY5)

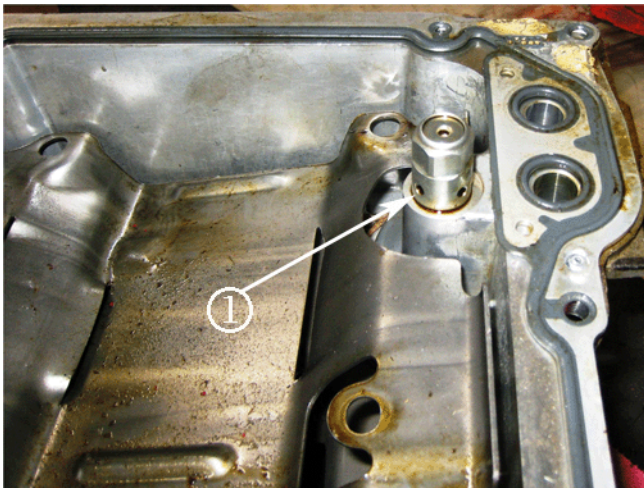
4. Remove the AFM valve (1).
