# Service Bulletin

**Subject:** Aftermarket ALDL or DLC Interface Devices Causing Multiple Issues

**Models:** 2006-2013 GM Passenger Cars and Trucks

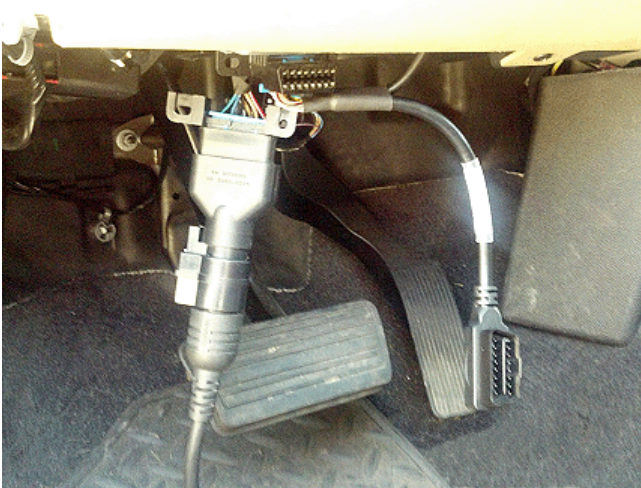
**Device W/Secondary DLC Connector**

This device has another DLC connector on it. The rest of the harness along with the device can be placed out of sight hidden from the technician, who may not notice the diagnostic connector is not in the factory location.

If the device is available, attempt to duplicate the condition, then remove the device to determine if the condition is eliminated. If confirmed, inform the customer of the issue and that they need to work with the supplier of the device for further resolution.
