Service Bulletin

PRELIMINARY INFORMATION

Subject: Broken or Separated Auxiliary Floor Mat Retainers, Floor Mat Retainer Won't Seat on Carpet

Models: 2010-2013 Buick LaCrosse
2011-2013 Buick Regal
2012-2013 Buick Verano
2008-2013 Cadillac CTS All Models including V-Series
2010-2013 Cadillac SRX
2011-2013 Chevrolet Cruze, Equinox, Volt
2012-2013 Chevrolet Sonic
2013 Chevrolet Malibu
2011-2013 GMC Terrain
2011-2013 Saab 9-4x

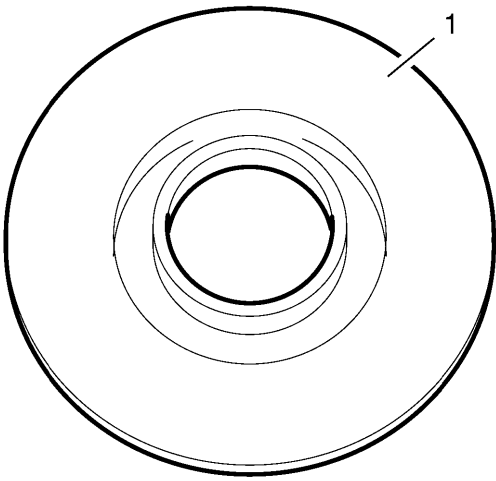
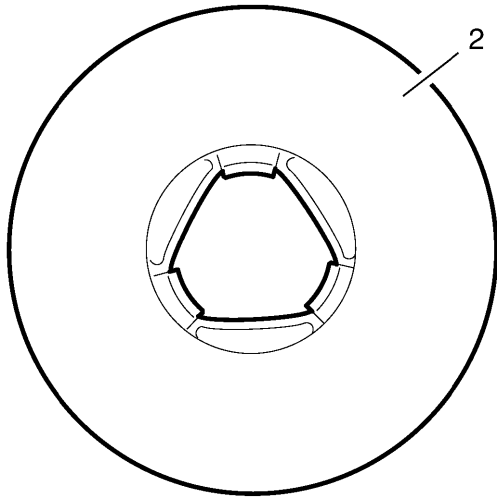
There are two different suppliers of auxiliary floor mat retainers for these vehicles, Saxonia and ITW, and the mat retainers and carpet retainers are NOT interchangeable between the two suppliers. Additionally, the ITW style have a first (V1.x) and second (V2.0) design. Look at the backside of the retainer on the auxiliary mat. If the center of the lower section is round, the retainer was made by Saxonia(1). If the center of the lower section has a triangle, the retainer was made by ITW (2). Furthermore, ITW V2.0 retainers can be identified by a "V2.0" embossed on the back side of the floor mat retainer.
