# Service Bulletin

**Subject:** Sunroof Rattle Noise When Glass Open and Driving Vehicle

**Models:** 2013 Cadillac ATS  
Equipped with Sunroof (RPO CF5) and Built Prior to VIN Breakpoint D0149142

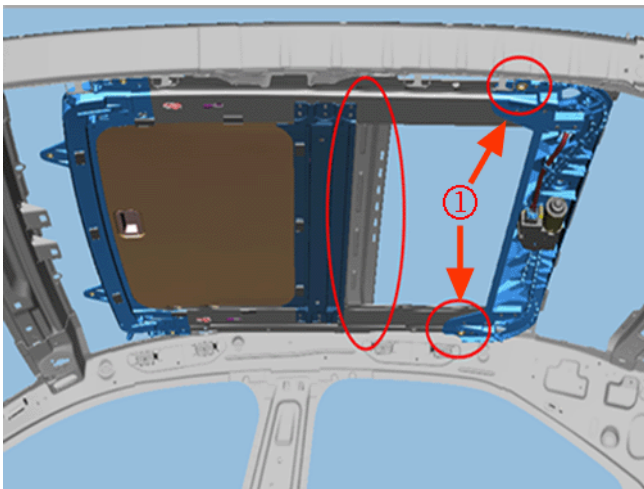
Some customers may comment on hearing a rattle noise coming from the sunroof when the glass is open and the vehicle is being driven. The condition is usually more evident when the vehicle is driven over bumpy surfaces.

The cause of this condition may be that, during production, the rear of the sunroof module was installed too high when the two rear leveling features (1) were not properly adjusted. When the sunroof glass is open, the distance between the glass and the roof structure #2 bow (shown circled above) is too narrow and contact of the glass to the roof bow may occur.

Design intent is to maintain a 5 mm (0.20 in) gap in the leveling nut during installation of the sunroof. The graphics above show the correct/incorrect gap. Verify the condition, then properly adjust the two rear sunroof leveling nuts following the steps below:

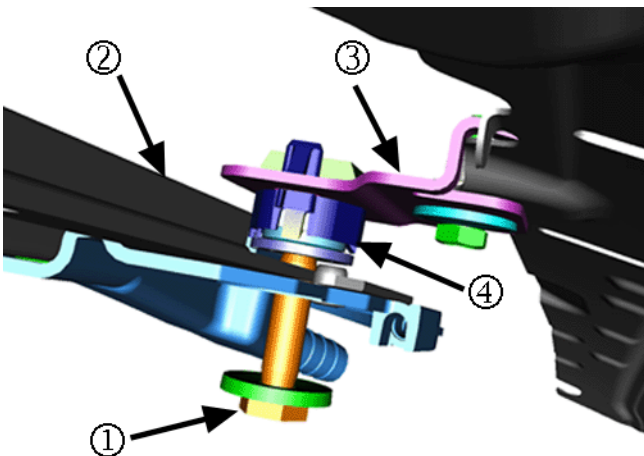
The two rear bolts (1) of the sunroof module (2) thread into a bracket (3), mounted to the roof structure on each side, which contain a unique leveling nut mechanism (4).

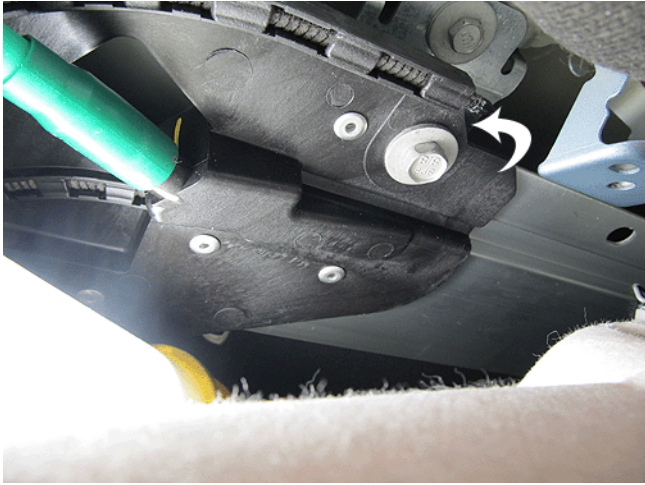
This leveling nut is sandwiched between the bracket and the topside of the sunroof frame, so it is not visible when the sunroof module is installed. A right rear view of the module is shown in the graphic above.

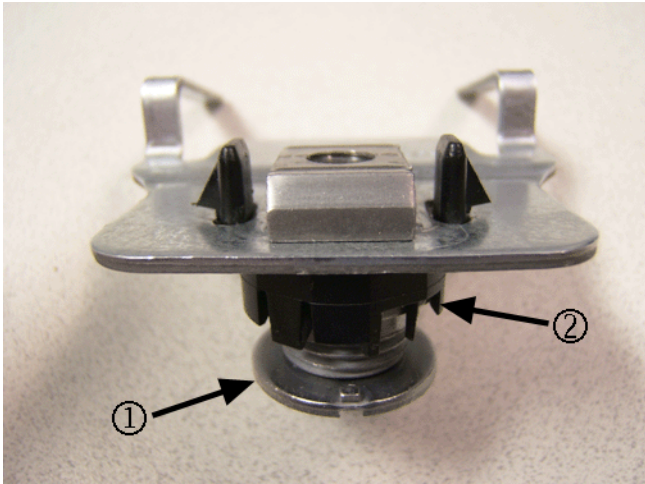
The washer insert (1) of the leveling nut has a reverse thread. Turning it clockwise will increase the gap between the washer and housing (2) and turning it counterclockwise decreases the gap. By design, when the sunroof bolt is installed into the leveling nut, the washer insert will thread downward and open the gap until the washer contacts the topside of the sunroof frame.
