Bulletin No.: Pl0659A

Service Bulletin

Subject: Groan, Squeak or Rubbing Type Noise When Turning Steering Wheel

Models: 2010-2013 Buick LaCrosse

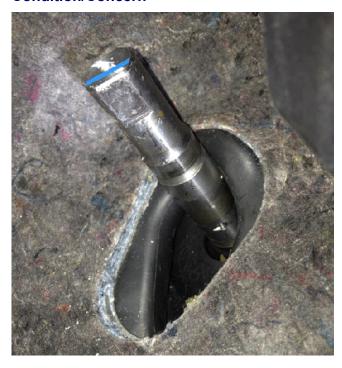
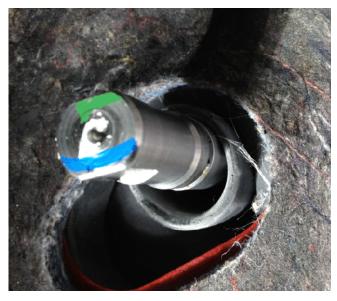
1

Some customers may comment on a rubber squeak type noise when turning the steering wheel. This condition may be caused by the seal for the intermediate shaft, located at the front of dash, rubbing on the rotating intermediate steering shaft. Refer to the pictures above. On electronic power steering (EPS) equipped vehicles, the EPS wire harness bracket may be contacting the steering column seal.

Technicians should inspect the steering column seal for proper installation by repositioning the inner intermediate steering shaft boot assembly to gain access. Inspect the seal at the front of the dash where the intermediate steering shaft passes through from the steering gear. Ensure that the seal is centered in the opening and around the intermediate steering shaft as shown above. If the seal is out of position, replace the steering column seal following the steps below.
