Front Door Glass Run Deformed

Service Category Vehicle Exterior

Section Window/Glass

YEAR(S)	MODEL(S)	ADDITIONAL INFORMATION
2012 – 2013	iQ

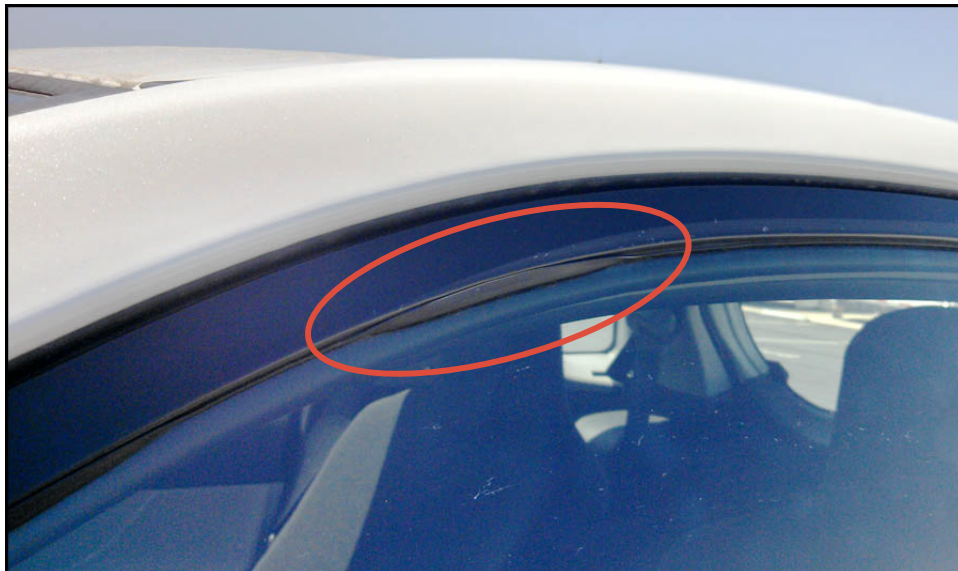
Some vehicles may exhibit a condition where the front door glass window run pulls out of the upper rear corner of the door frame or otherwise becomes deformed during operation of the window. A new front door glass run weatherstrip is now available to address this condition.

1. Confirm window run is deformed or being pulled out of upper rear corner of door frame.
2. Confirm correct replacement part based on door frame channel design (see Parts Information).
3. Replace the door glass run.

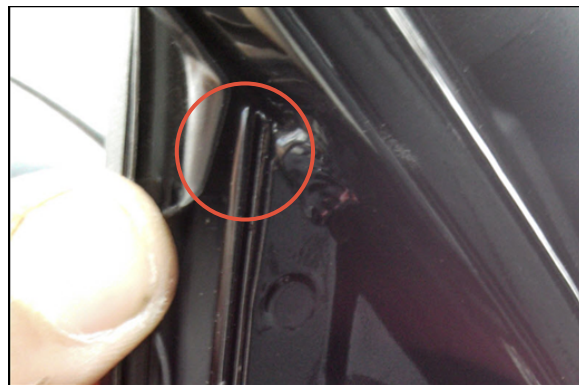
Figure 1. Early Design - Extended Window Channel Edge

1. If vehicle is equipped with the early design door frame channel (Figure 1), use the table below.

PART NUMBER		PART NAME	QTY
PREVIOUS	NEW		
68141-74011 68141-74020	68141-74021	Run, Front Door Glass, RH	1
68151-74011 68151-74020	68151-74021	Run, Front Door Glass, LH	1

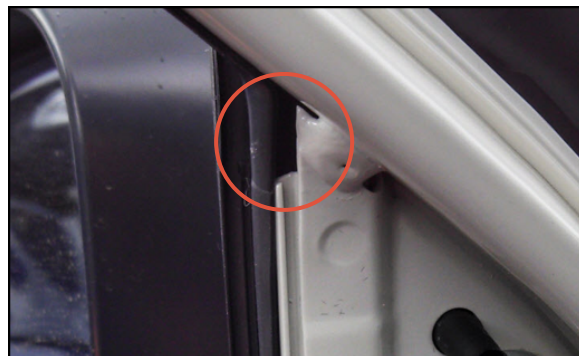
Figure 2. Late Design - Shorter Window Channel Edge

2. If vehicle is equipped with the late design door frame channel (Figure 2), use the table below.

PART NUMBER		PART NAME	QTY
PREVIOUS	NEW		
68141-74011	68141-74012	Run, Front Door Glass, RH	1
68151-74011	68151-74012	Run, Front Door Glass, LH	1
