Navigation System Firmware Update

Service Category Audio/Visual/Telematics

Section Cellular Communication

YEAR(S)	MODEL(S)	ADDITIONAL INFORMATION
2013	GS350, GS450H, LX570, RX350, RX450H

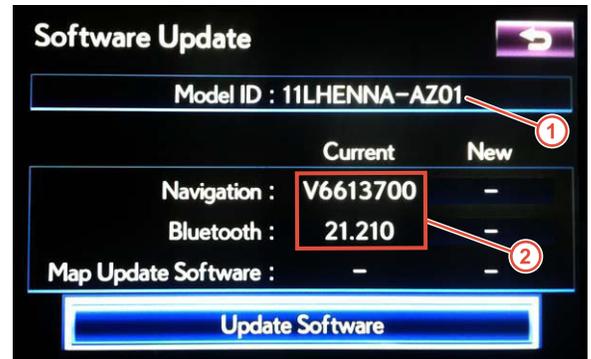
Figure 5.

1	ID Varies According to Vehicle
2	Current Version Is Displayed

7. Connect USB memory stick for the update.

- If the current version is "V6613850" or greater, STOP — This bulletin does NOT apply.
- If the current version is less than "V6613850", proceed to step 8.

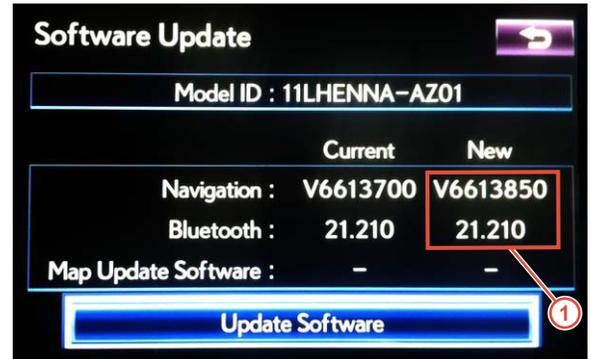
Figure 6.

1 Version to Be Updated Is Displayed

8. Press *Update Software*.
