Bluetooth and Phone Menu Icons Unavailable

Service Category Audio/Visual/Telematics

YEAR(S)	MODEL(S)	ADDITIONAL INFORMATION
2013	Land Cruiser	Serial Number Range(s): 000001–014886 WMI(s): JTM

Some 2013 model year Land Cruiser vehicles may exhibit a Bluetooth® inoperative condition where Phone and Bluetooth® menu icons are grayed out and cannot be accessed. A navigation firmware update has been developed to address this condition.

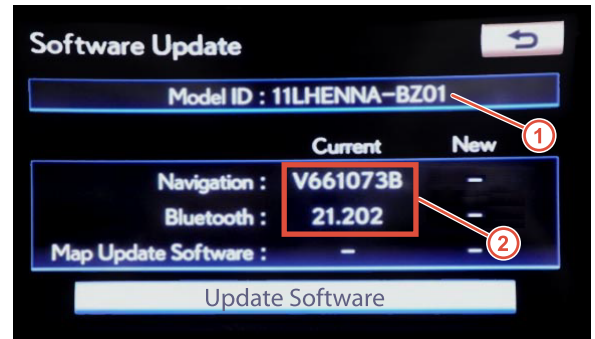
Figure 5.

1	ID Varies According to Vehicle
2	Current Version Is Displayed

7. Connect USB memory stick for the update.

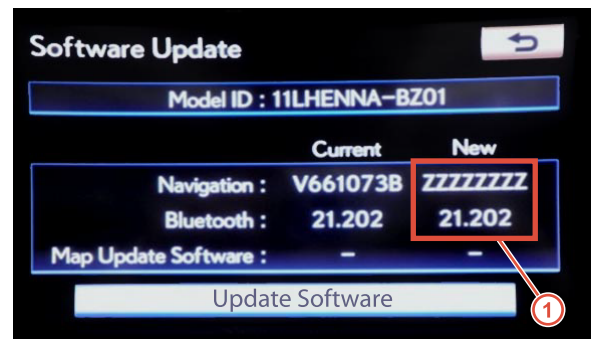
Figure 6.

1	Version to Be Updated Is Displayed
---	------------------------------------

8. Press "Update Software".
