# Abnormal Chirp or Squeak Noise from High Pressure Fuel Pump

YEAR(S)	MODEL(S)	ADDITIONAL INFORMATION
2013	FR-S

Some vehicles may exhibit a high pitch chirp or squeak noise from the High Pressure Fuel Pump Assembly when the engine is fully warmed up and idling. Follow the procedure in this bulletin to address this condition.

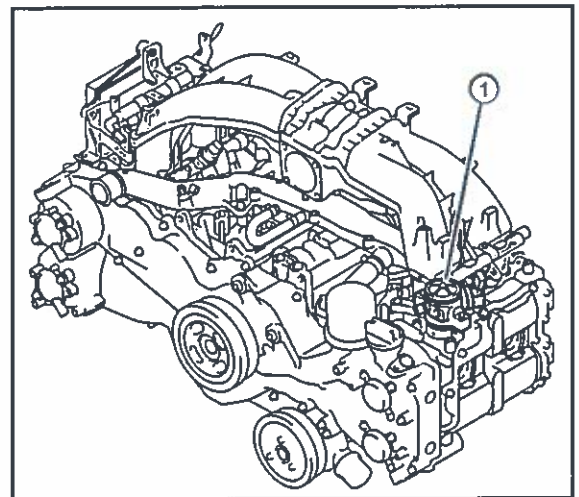
Figure 1.

1. Road test the vehicle for at least 10 minutes so that the engine is fully warmed up.
2. While the engine is idling, listen for abnormal noise from the High Pressure Fuel Pump Assembly.

- A mechanical ticking noise from the High Pressure Fuel Pump Assembly is normal during Direct Injection system operation.
- This bulletin should only be performed if an abnormal high pitch chirp or squeak noise from the High Pressure Fuel Pump is verified.

1 Fuel Pump Assembly (for High Pressure)

4. Replace the High Pressure Fuel Pump Assembly.
