# MIL "ON" DTC P014C, P014D, P014E, or P014F

## Applicability

YEAR(S)	MODEL(S)	ADDITIONAL INFORMATION
2010 – 2012	IS250	Transmission(s): 6AT
2010 – 2012	IS250C	Transmission(s): 6AT

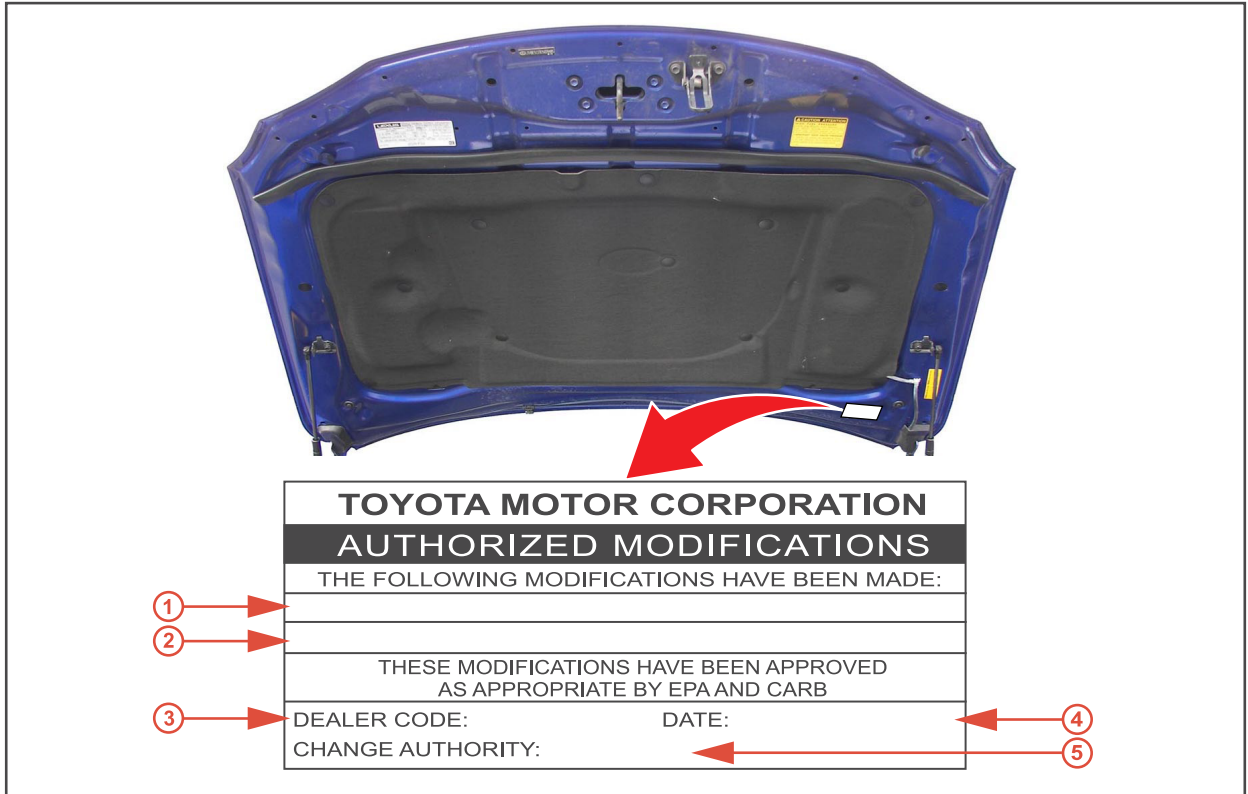
Figure 1. Location of Authorized Modifications Label on 2010 – 2012 IS 250/250C

2. Check for the Authorized Modifications Label affixed to the vehicle in the location shown in Figure 1. Confirm if the ECM (PCM) calibration has been updated. If the calibration ID listed is NOT the latest ECM (PCM) calibration — go to step 3.

4. Install the Authorized Modifications Label.
  - A. Using a permanent marker, enter the following information on the label:
    - ECM part number [*Refer to the **Parts Information** section for the **CURRENT PART NUMBER***]
    - Calibration ID(s) [*Refer to the **Calibration Identification Chart** for the **NEW CALIBRATION ID***]
    - Dealer Code
    - Repair Date
    - Change Authority [***This bulletin number***]
  - B. Affix the Authorized Modifications Label to the vehicle at the location shown in Figure 1. The Authorized Modifications Label is available through the MDC, P/N 00451-00001-LBL.
5. Test drive the vehicle to confirm proper vehicle operation.
