# Repair Manual Supplement: Vehicle Pulling to One Side

**Service Category** Suspension

**Section** Alignment/Handling Diagnoses

YEAR(S)	MODEL(S)	ADDITIONAL INFORMATION
2002 – 2014	4Runner, Avalon, Camry, Corolla, Highlander, Land Cruiser, Prius, RAV4, Sequoia, Sienna, Solara, Tacoma, Tundra	
2007 – 2014	Camry HV, FJ Cruiser	
2002 – 2005	Celica, Echo, MR2 Spyder	
2006 – 2014	Highlander HV	
2003 – 2014	Matrix	
2002 – 2008, 2010	Solara	
2009 – 2014	Venza	
2004 – 2014	Yaris

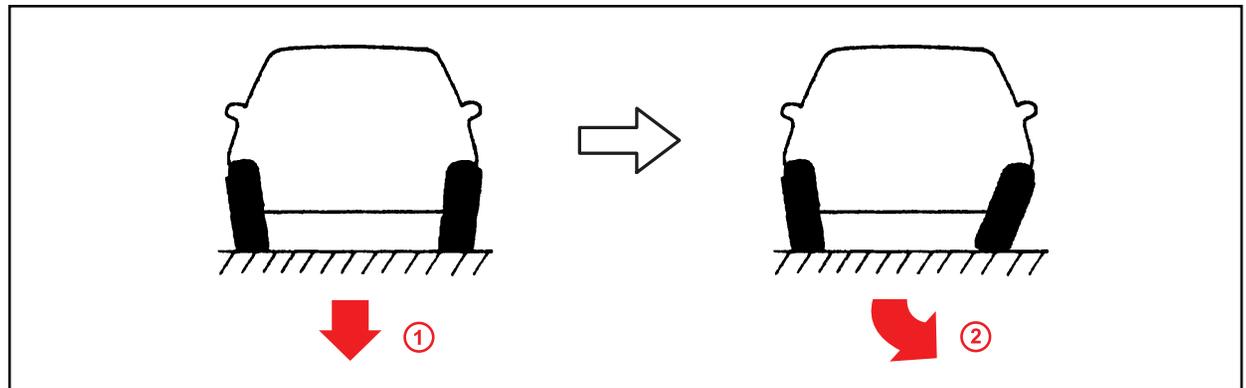
**Figure 1. Camber**

When the cross camber or caster of the front wheel alignment is large, it can cause vehicle pulling.

WHEEL ALIGNMENT	DIRECTION OF VEHICLE PULLING
Camber	Vehicle Pulls in Direction of Wheel with Increasing Camber Value (Figure 1)
Caster	Vehicle Pulls in Direction of Wheel with Decreasing Caster Value (Figure 2)

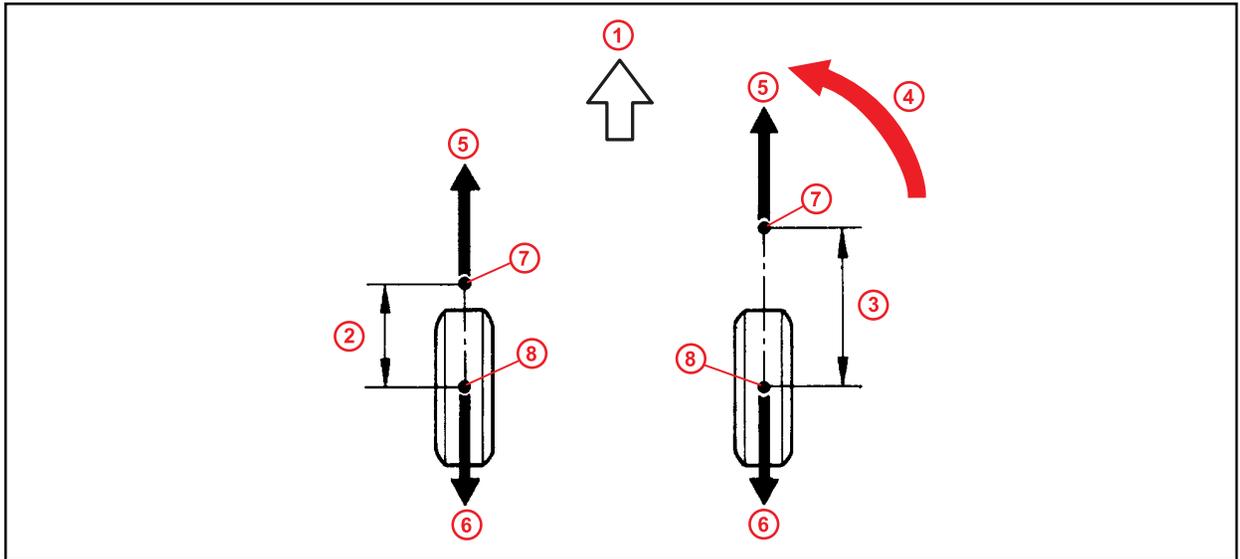
Figure 2. Caster

If the cross camber or caster is within the specified range (30' or less), noticeable vehicle pulling will not occur due to side-to-side differences in camber or caster.

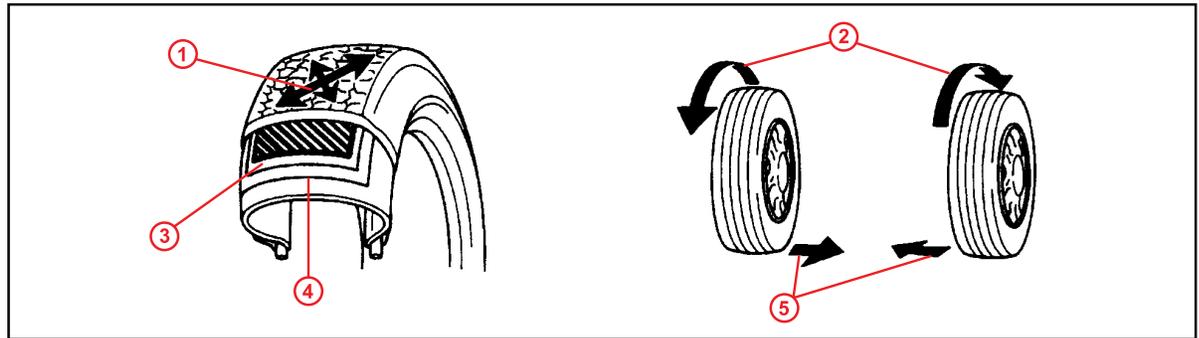
Figure 3.

Lateral force due to ply-steer is produced by the construction of the belts inside the tire tread. With radial tires, the wire of the belt is slanted as shown in the illustration below. Thus, it is in the lateral direction that tire tread easily changes shape (stretches), and lateral force is generated between the tire and the road surface in the lateral direction.

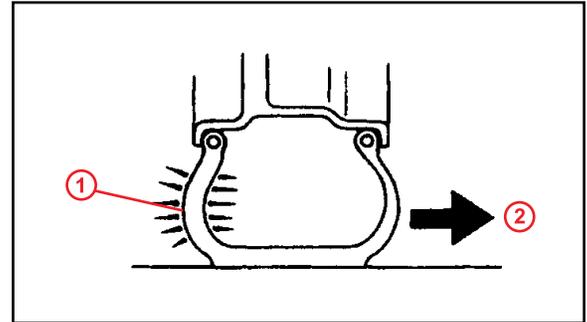
Figure 4.

Conicity is lateral force resulting from uneven formation of the left and right sides of the tire. The direction the lateral force is exerted depends on the hardness of the side walls and the difference in height between the left/right sides of the tire.

- In the case of vehicle pulling caused by tires, the lateral force which is exerted as a result of conicity has the greatest effect. On a flat road, if the steering wheel is held without exerting steering effort for 109 yards (100 m) when traveling at 62 mph (100 km/h), the vehicle may drift as much as 5 feet (1.5 m).
- When vehicle pulling is due to conicity, the amount of drift can be reduced and the direction of drift can be changed by changing the location of the tire or reversing the tire when installing it on the wheel.

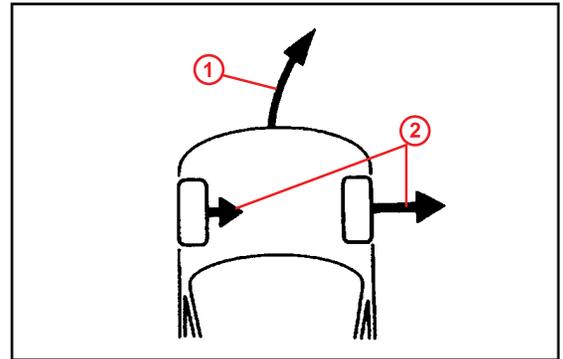
**Figure 6. Original Tire Positions**

- The direction of lateral force from tire conicity becomes reversed when the left and right tires are switched. Therefore, if the pulling direction changes when the tires are switched, it can be concluded that vehicle pulling is caused by tire conicity.
  - The vehicle is pulled to the right by the lateral force exerted to the right.

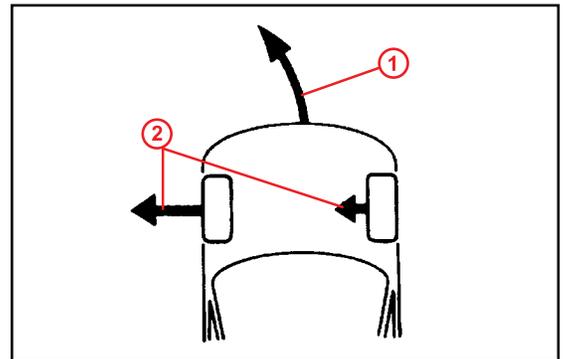
**Figure 7. Tires Switched**

- The direction of the tires which exerted lateral force to the right has been changed, so the tires now exert lateral force to the left and the vehicle now pulls to the left.

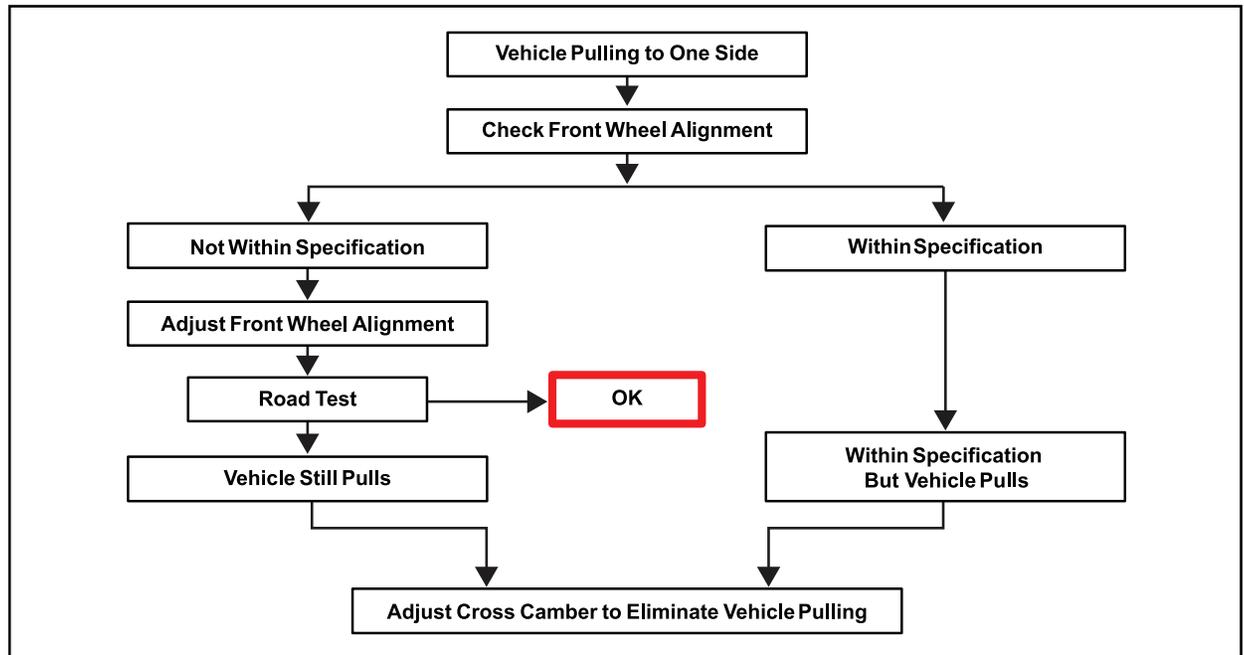
Figure 8.

When it is determined by troubleshooting that the vehicle pulling to one side is caused by wheel alignment, perform repairs according to the following procedure.

WHEN VEHICLE PULLS TO LEFT	WHEN VEHICLE PULLS TO RIGHT
Increase right front camber and decrease left front camber until vehicle pulling is eliminated	Increase left front camber and decrease right front camber until vehicle pulling is eliminated

- Keep the cross camber within 1° or less.
- Keep the camber of each wheel within specifications (+/-45' of center value).
- If adjustment exceeds the specifications, uneven tire wear will result.

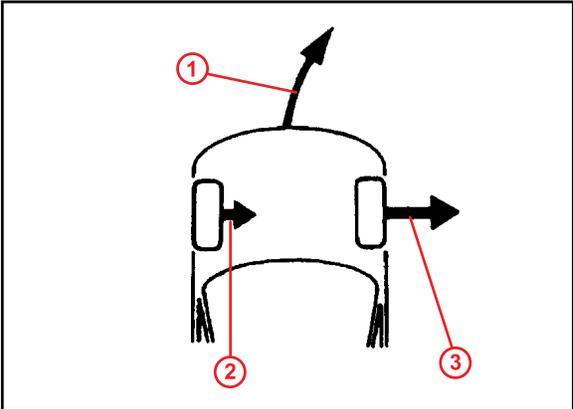
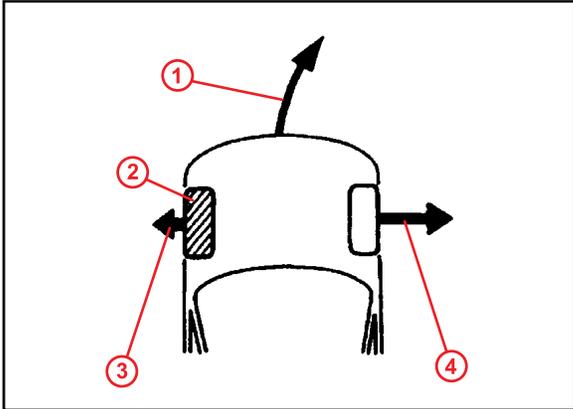
The lateral force generated by the right front tire is greater than the left tire, so the vehicle is pulling due to the lateral force of the right tire.

- A. Remove the front left tire from the wheel and reverse the tire. Then perform a road test and check for change in the pulling direction.

**If Vehicle Pulls in the Same Direction: Go to step 3B.**

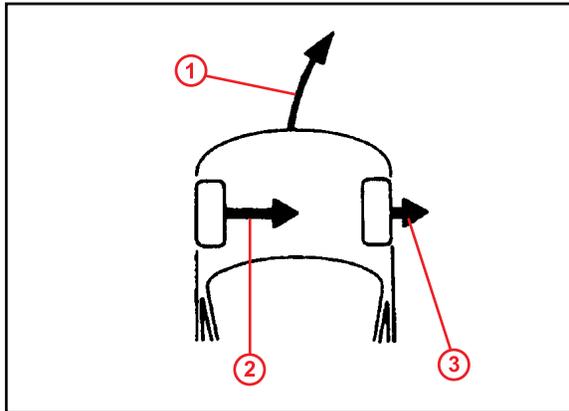
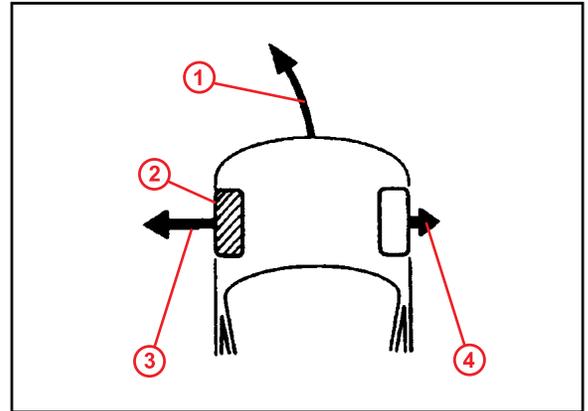
The lateral force generated by the left front tire is greater than the right tire, so the vehicle is pulling due to the lateral force of the left tire.

**If Vehicle Pulls in the Opposite Direction: Go to step 3B.**
