Center Console Garnish Attachment Improvement

YEAR(S)	MODEL(S)	ADDITIONAL INFORMATION
2013	GS350, GS450H

Some vehicles may exhibit the right and/or left center console garnish becoming loose from the center console at the rear-most area of the center console. Follow the repair procedure in this bulletin to address this condition.

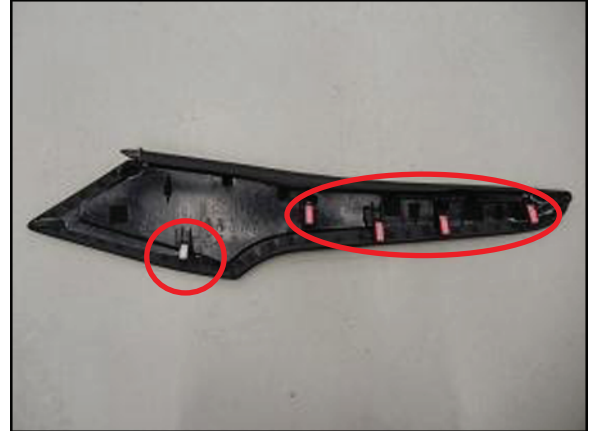
Figure 2.

Moving from left to right, the white clip is in position 1 and the farthest clip to the right is in position 5.

2. Remove and discard the 5 clips attached to the center console side garnishes.

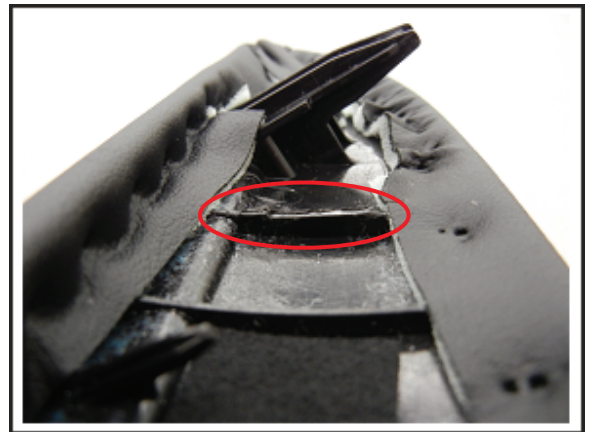
Figure 10. View of Rib with Top Portion Removed
