# AB60F Transmission Clutch/Brake Damage

YEAR(S)	MODEL(S)	ADDITIONAL INFORMATION
2008 – 2011	LX570	Engine(s): 3UR Transmission(s): 6AT VDS(s): HY00W, HY7AX

Some 2008 – 2011 model year LX 570 vehicles may exhibit a MIL “ON” condition with transmission performance DTCs such as P2714, P0751, P0756, P0761, P0766, P0729, P0781, P0894, P2757, or P0776 and/or abnormal transmission shifting. Revised Engine Control Module/ECM (SAE term: Powertrain Control Module/PCM) software logic has been developed to address this condition. In some cases, replacement of the automatic transmission may also be required.

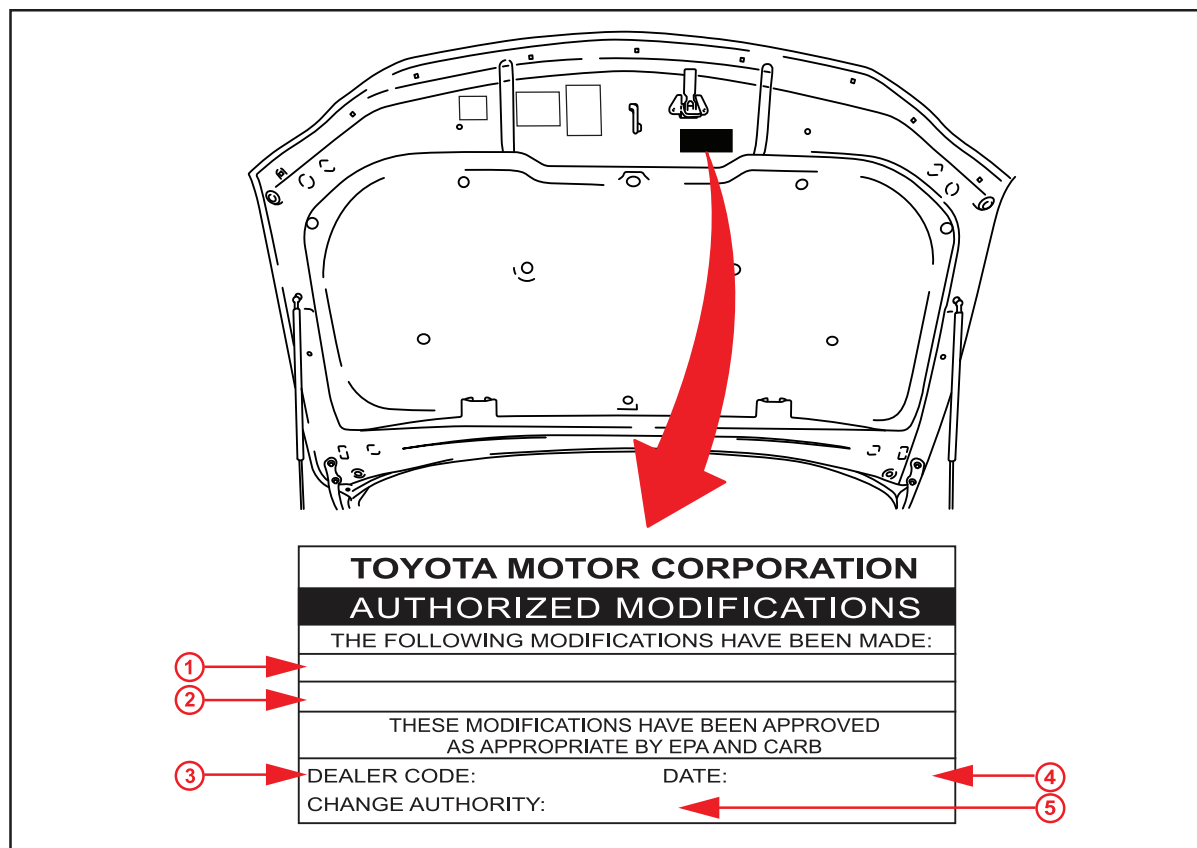
**Figure 1. Location of Authorized Modifications Label on 2008 – 2011 LX 570**

- A. Check for the Authorized Modifications Label affixed to the vehicle in the location shown in Figure 1. Confirm if the ECM (PCM) calibration has been updated. If the calibration ID listed is NOT the latest ECM (PCM) calibration, go to step B.

##### B. Affix the Authorized Modifications Label to the vehicle at the location shown in Figure 1. The Authorized Modifications Label is available through the MDC, P/N 00451-00001-LBL.
