# Moisture in Rear Combination Light / Water Intrusion Into Vehicle

## Applicability

YEAR(S)	MODEL(S)	ADDITIONAL INFORMATION
2013	FR-S

## Introduction

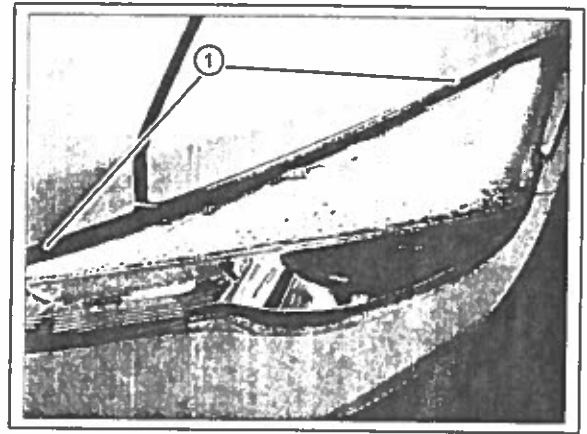
Figure 1.

1. Prior to making any repairs or replacing parts, locate the source of water entry.
2. See Figure 1 for an example of moisture inside the Rear Combination Light.

1	Interior Moisture
---	-------------------

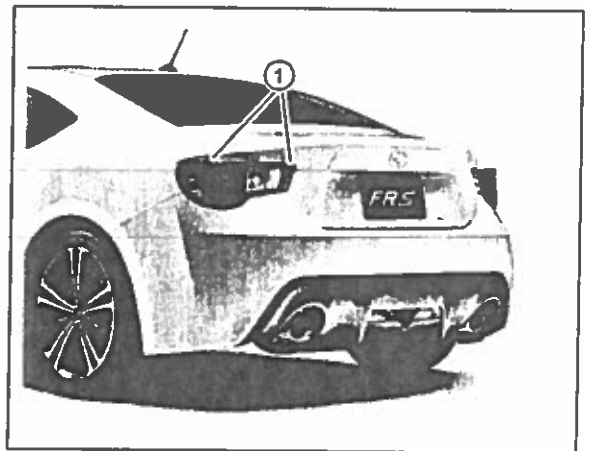
Figure 2.

4. Spray water on the vehicle, especially around the perimeter of the light housing.

1	Spray Location
---	----------------

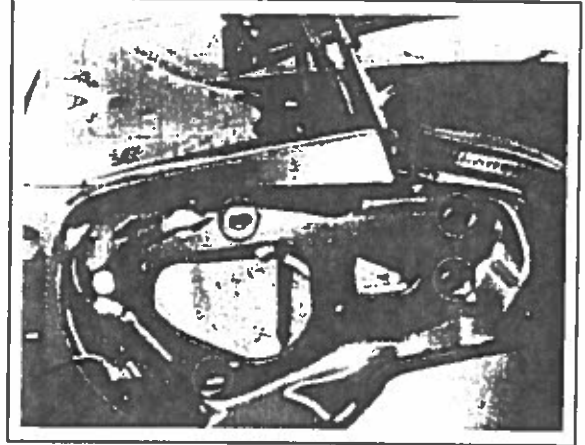
Figure 5.

2. Inspect the body sheet metal for evidence of deformed (cone shape) sheet metal around the 4 through-holes in the body.

Use a Body Hammer and Body Dolly to flatten the sheet metal around the 4 through-holes in the body (see circled areas for through-hole locations). Use touch-up paint on any bare metal areas.
