MIL "ON" DTC P0017 or P0019

Service Category Engine/Hybrid System

Section Engine Control

YEAR(S)	MODEL(S)	ADDITIONAL INFORMATION
2013	FR-S

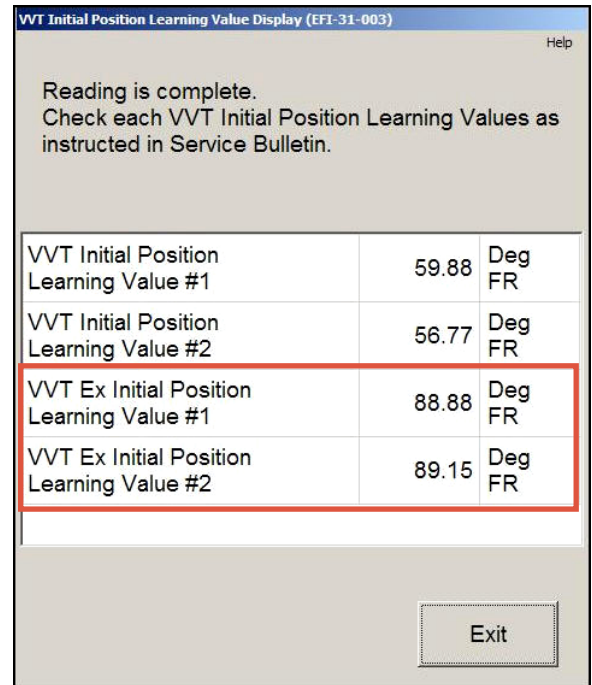
Figure 1.

1. Confirm DTC P0017 or P0019 is set.
2. Using the Techstream Utility "VVT Initial Position Learning Value Display", confirm the VVT Ex Initial Position Learning Value #1 and #2 are within the range.

RANGE (IN DEGREES)	
	MINIMUM	MAXIMUM
VVT Ex Initial Position Learning Value	85.0	95.0

- **YES** — Proceed to step 4 (Reprogram the ECM).
- **NO** — Proceed to step 5 (Replace the ECM).

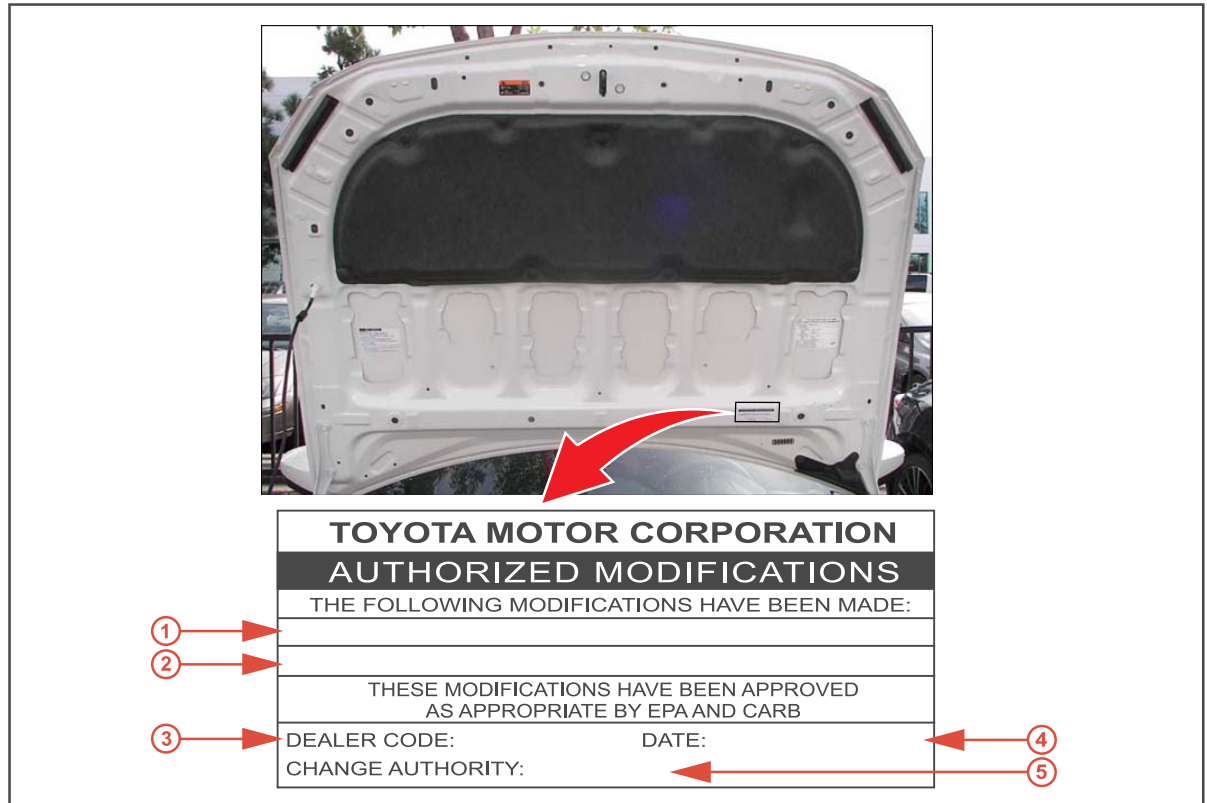
Figure 2. Location of Authorized Modifications Label on 2013 FR-S

A. Check for the Authorized Modifications Label affixed to the vehicle in the location shown in Figure 2. Confirm if the ECM (PCM) calibration has been updated. If the calibration ID listed is NOT the latest ECM (PCM) calibration — go to step 4.B.

- (2) Affix the Authorized Modifications Label to the vehicle at the location shown in Figure 2. The Authorized Modifications Label is available through the MDC, P/N 00451-00001-LBL.
