Service Bulletin

Subject: Revised Liftgate Strut Replacement Procedure

Models: 2008-2012 Buick Enclave
2009-2012 Chevrolet Traverse
2007-2012 GMC Acadia
2007-2010 Saturn OUTLOOK

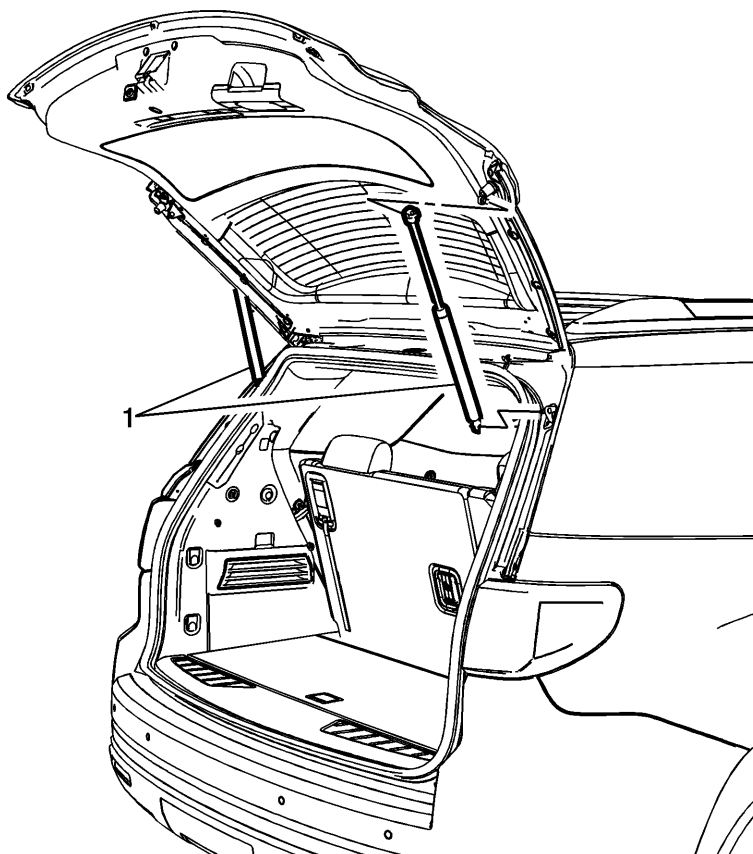
GM engineering has determined that improved durability of the liftgate strut can be realized by installing the strut assembly with the rod side down. In this orientation, dust and dirt does not collect on the strut housing to rod seal, which can cause wear on the seal.

When it is necessary to replace a liftgate strut, install the strut assembly with the strut body end attached to the body side of the vehicle and the rod side attached to the liftgate (1).

Important: This revised installation procedure applies to all vehicles even if the struts were installed in a different orientation from the factory.
