Service Bulletin

PRELIMINARY INFORMATION

Subject: Exhaust Leak or Vibration/Rattle Noise at Approximately 900 RPM, Fuel Smell, White Smoke, Oily Substance on Exhaust Downpipe

Models: 2011-2013 Chevrolet Express 2500/3500/4500, Silverado 2500HD/3500HD
2011-2013 GMC Savana 2500/3500/4500, Sierra 2500HD/3500HD
Equipped with 6.6L Duramax™ Diesel Engine (RPOs LML or LGH)

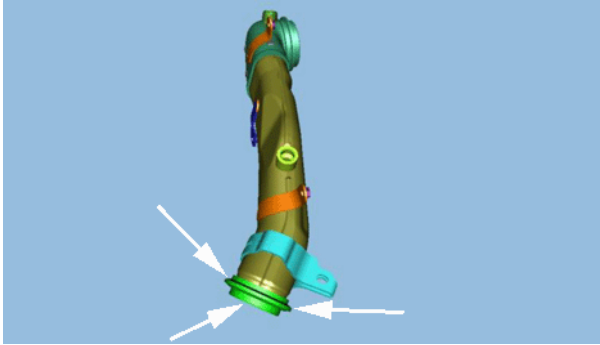
Note: The illustration above is the updated turbocharger exhaust pipe with a pilot flange.

If the above alignment procedure does not correct the condition, the turbocharger exhaust pipe may need to be replaced on trucks built prior to the breakpoints listed below with an updated turbocharger exhaust pipe with a pilot flange. If the turbocharger exhaust pipe has the new flange, you should not need to replace it. Refer to the Turbocharger Exhaust Pipe Replacement procedure in SI.

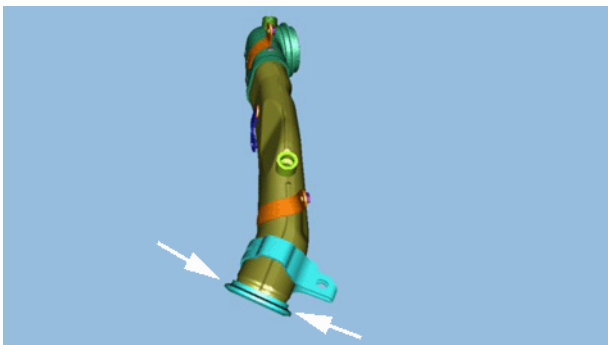
Note: The illustration above is the turbocharger exhaust pipe without a pilot flange.

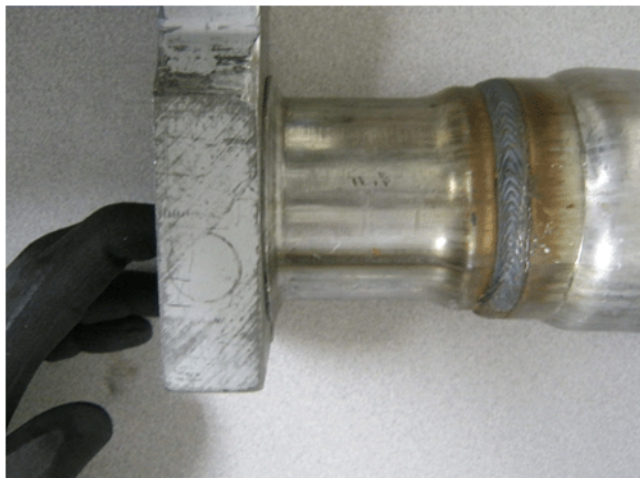
In most cases it will not be necessary to replace the exhaust downpipe/catalytic converter assembly for this condition. However if the mating flange on the exhaust downpipe/catalytic converter assembly is not true, it is possible a leak may occur.

This can be inspected easily by placing a gauge block flush against the flange and inspect for excessive gaps or damage to the flange.

If there are gaps, the converter may need replacing, but the new gasket should compensate for minor surface variation. It is preferred that the alignment

process is attempted prior to replacing the converter. There have been very few cases that required the converter to correct this condition.
