Service Bulletin

PRELIMINARY INFORMATION

Subject: Road Debris (Mud) on Rocker Panel at Front Door Area

Models: 2010-2013 GMC Terrain

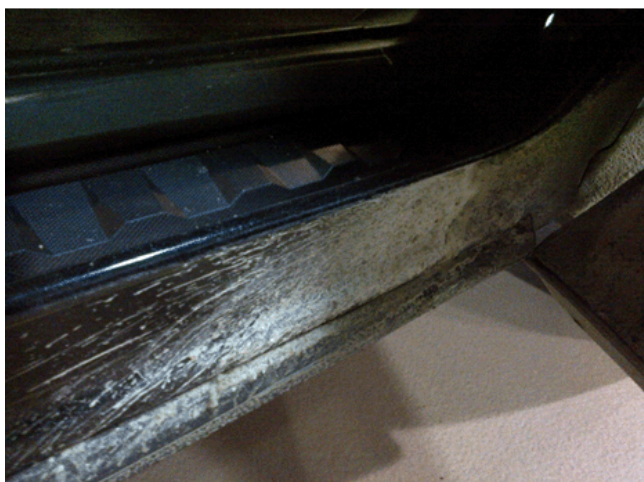
Some customers may comment that road debris (mud) is traveling up between the front doors and the rocker panels.

This condition may be caused by debris working around the front of the door seal.

Note: Whenever you drill into a metal surface, the corrosion resistance of that panel is compromised. Treat the drilled holes with GM Super Lube® to prevent corrosion.

The installation of GM accessory splash guards will direct the debris away from the door seal and prevent mud from working into the rocker panel area.

Splash guards are available as P/N 19170501 for front splash guards only, or P/N 19170503 for all four splash guards.
