Service Bulletin

Subject: Diagnostic Tips for Steering Gear Boot Stains, Perceived Fluid Leak from Power Steering Gear End Seals

Models: 2008-2013 Buick Enclave
2009-2013 Chevrolet Traverse
2007-2013 GMC Acadia
2007-2010 Saturn OUTLOOK

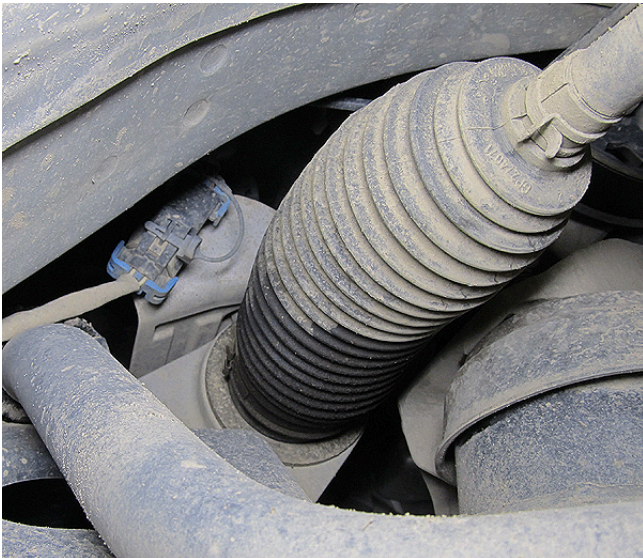
Technicians may notice a stain or shadow on the lower side of the steering gear boot bellows. These stains may be diagnosed as a leak from the rack housing end seals, allowing the fluid to leak into the boot and creating the stain.

Analysis has revealed that the stain is due to the gear assembly grease becoming liquefied from heat and collecting in the bellows of the boot causing the stain. This staining should be considered normal, especially for the RH boot, which is closest to the exhaust.

Do not replace the steering gear for this staining unless the vehicle has evidence of a loss of fluid from the pump reservoir with no external leaks.

If the vehicle has a history of a fluid loss from the reservoir with no signs of external leaks, diagnosis should include inspecting the inside of the steering gear boots for the presence of fluid using the procedure below. Only under these circumstances should the gear be replaced for the end seal leak.
