# Service Bulletin

**Subject:** Passenger Side Defrost Air Flow/Performance and/or Temperature Less Warm Than Drivers Side in Defrost, IP Vent or Heat Modes

**Models:** 2012-2013 Cadillac Escalade Models  
2012-2013 Chevrolet Avalanche, Silverado, Suburban, Tahoe  
2012-2013 GMC Sierra, Sierra Denali, Yukon Models  
Excluding Crew Cab and Extended Cab with Single Zone Air Conditioning (RPO C67)

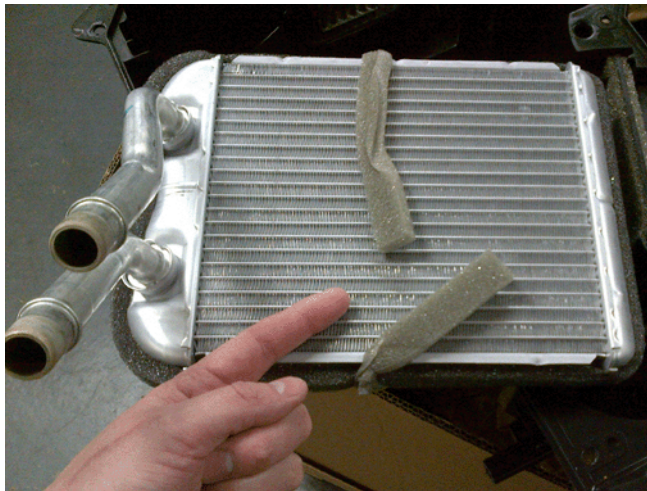
The cause of this condition may be that the belt seal (1) that goes around the heater core may have become mis-positioned. If this occurs, it can create a path for air to travel to the wrong side of the HVAC Module.

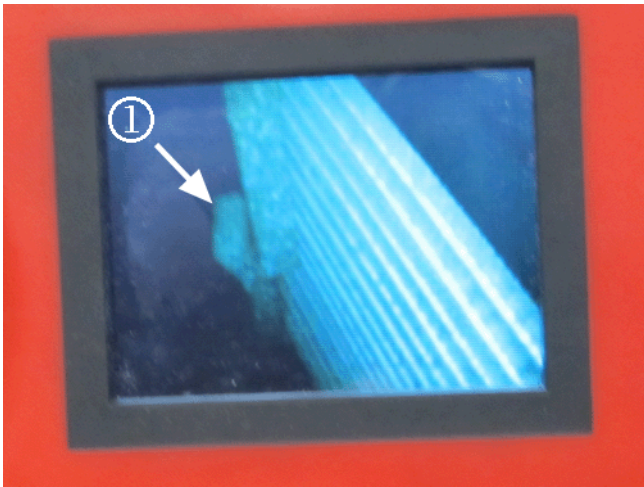
- If the belt seal (1) is rolled or mis-positioned (as shown in the graphic above), install the push pin to the drilled access hole in the HVAC case as described in step #7, then R&R the heater core and replace the heater core belt seal following Heater Core Replacement in SI.
- If the belt seal is properly positioned, complete steps #7-10, then refer to SI for any further recommended HVAC diagnostics.
