Service Bulletin

Subject: Pop or Clunk Noise When Turning Steering Wheel at a Stop or Low Speeds

Models: 2010-2013 Chevrolet Impala

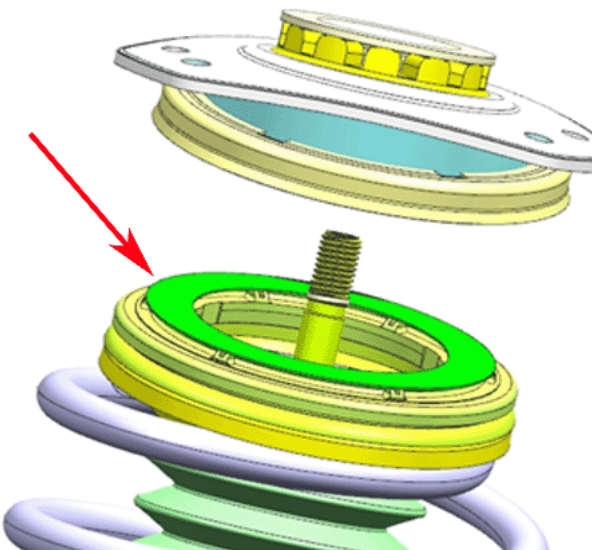
Some customers may comment on a clunk or pop type noise when turning the steering wheel at a stop or at low speeds.

Install the strut spacer as shown above. Refer to Strut, Strut Component, or Spring Replacement in SI.
