# Service Bulletin

## PRELIMINARY INFORMATION

**Subject:** Front Sunroof Sunshade Will Not Latch or is Difficult to Latch in the Closed Position

**Models:** 2010-2014 Buick Enclave  
2010-2014 Chevrolet Traverse  
2010-2014 GMC Acadia  
2010 Saturn OUTLOOK  
Equipped with Sunroof RPO C3U  
and Built After August 1, 2009

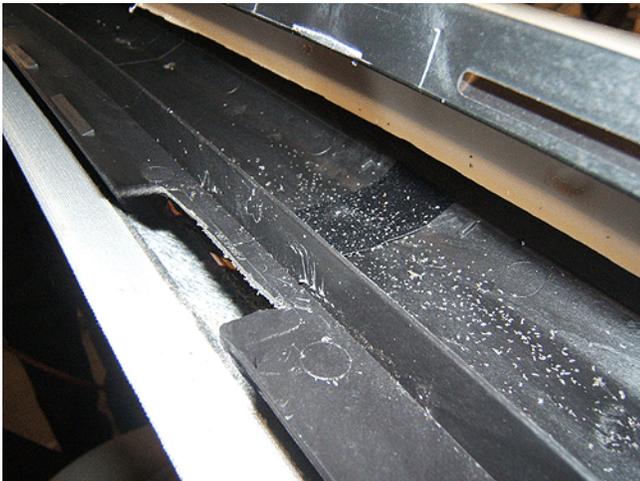
Some customers may comment that the front sunroof sunshade will not latch in the closed position.

The molded-in sunroof sunshade striker on the sunroof module may be broken.

Replace the front sunroof sunshade striker with the service replacement striker by riveting it to the sunroof module assembly.

1. Check that the sunroof sunshade striker fits into where the broken striker was by placing the sunroof sunshade striker under the bottom of the front rail. File to fit if necessary.
2. Place the sunroof sunshade striker on the top surface of the front rail to locate the holes. Mark the hole locations.

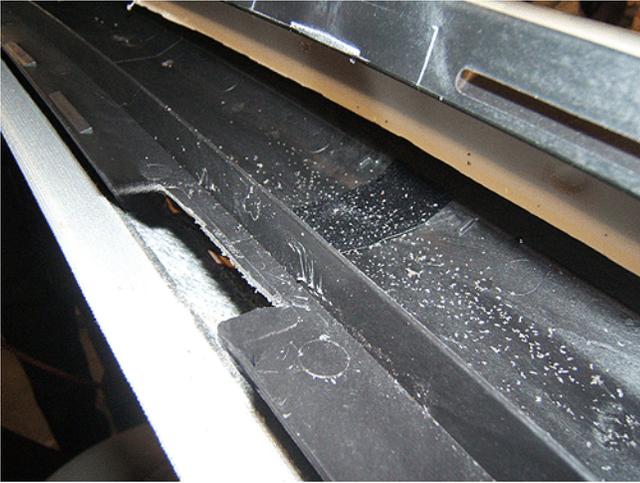
Some customers may comment that the front sunroof sunshade is difficult to latch in the closed position.

The front rail of the sunroof module may sag due to high ambient temperatures causing the sunshade striker to sit lower. This is more prevalent on dark colored vehicles when parked in direct sunlight for an extended period of time.

Remove the existing molded-in sunroof sunshade striker and install the service replacement striker by riveting it to the sunroof module assembly.

**Important:** When removing the striker, be careful not to cut/damage the headliner.

1. Remove the existing sunshade striker using a Dremel or similar tool.
2. Place the sunroof sunshade striker on the top surface of the front rail to locate the holes. Mark the hole locations.
