Service Bulletin

Subject: Inspect XM/Cellular Mobile Phone/OnStar® Antenna for Looseness or Damage, XM/Cellular/OnStar® Reception Performance Degraded, Rattle/Flutter/Squeak Noise, Wind Noise/Whistle at Highway Speeds, Water Leak on Headliner at Sunvisor

Models: 2010-2014 Cadillac Escalade Models
2010-2013 Chevrolet Avalanche, Silverado LD Models
2010-2014 Chevrolet Silverado HD, Suburban, Tahoe
2010-2013 GMC Sierra LD Models
2010-2014 GMC Sierra HD Models, Yukon Models

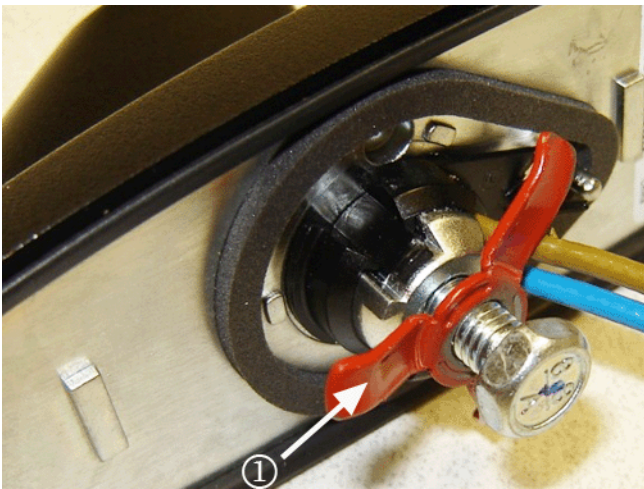
The cause of this condition may be looseness and/or damage of the XM/cellular mobile phone/OnStar® antenna, which may affect the grounding of the antenna and may allow a rattle/wind noise at highway speeds and/or a water leak.

Though difficult to detect evidence of impact damage, upon inspection of the antennas returned in warranty, there is a likelihood this damage occurred during vehicle transportation to dealerships. The result of impact damage is most often to the underside retainer (1), which is found to be bent backward or otherwise damaged and no longer provides proper retention.

If the antenna is loose or damaged, it must be replaced. Refer to Cellular Communications/Digital Radio Antenna Replacement in SI.

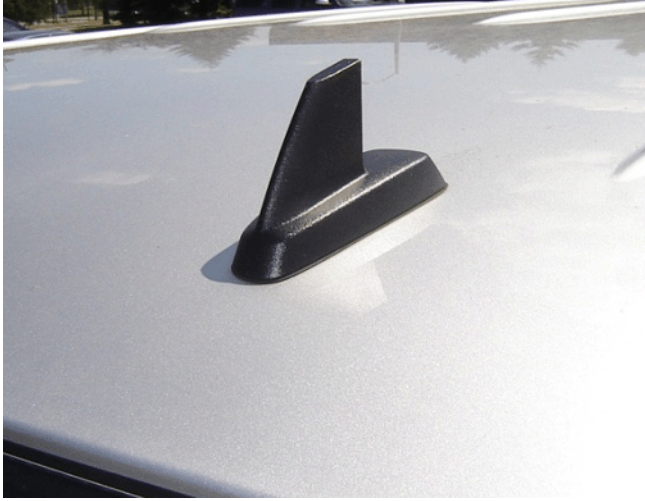
Grasp and physically inspect the XM, cellular mobile phone, and/or OnStar® antenna for looseness and/or damage. If the antenna is mounted securely and exhibits no signs of physical damage, follow regular diagnostic information in SI to address any customer concern.
