# Service Bulletin

**Subject:** Transmission Shudder or Bucking Feel (Follow Procedure Outlined Below)

**Models:** 2009 Cadillac Escalade  
2008-2009 Chevrolet Tahoe  
2008-2009 GMC Yukon  
Equipped with 2 Mode Hybrid Automatic Transmission (RPO M99)  
Built Prior to Serial Date 8010017028

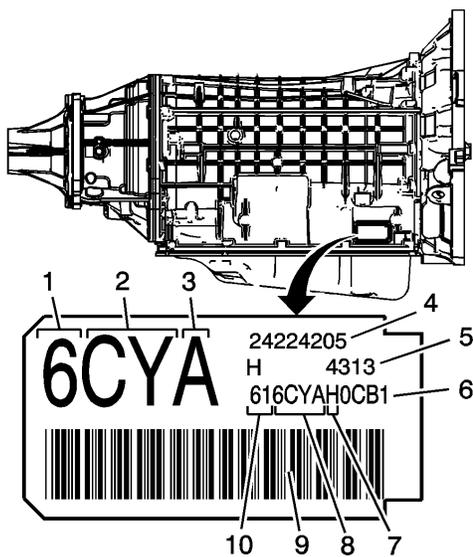
Refer to the illustration above to locate the sequential serial number (6).

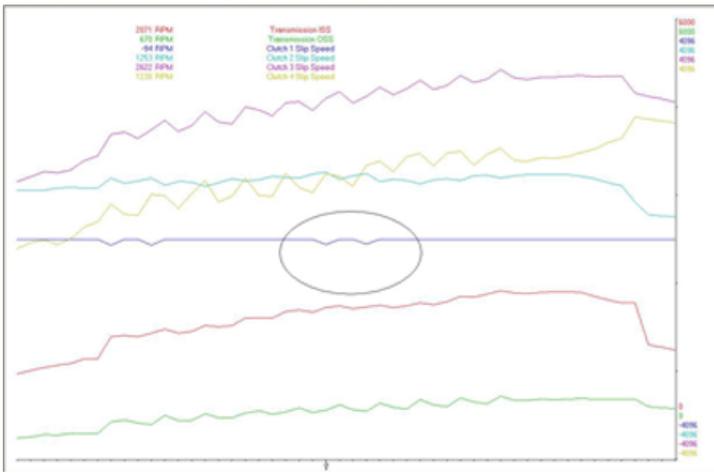
To verify the concern is caused by the orifice, monitor the Hybrid Low 1-2 clutch slip speed (clutch 1 on the scan tool). Normal clutch slip speed should be 0 rpm. If the slip speed varies either positive or negative slip rpm, or causes other clutch slip speeds to read erratic, the orifice is most likely restricted (see scan tool screen shot below showing variation of the clutch 1 slip speed (circled area). Normal reading would have a flat line (0 rpm).
