# Service Bulletin

**Subject:** Exterior Roof Panel Sag/Depression

**Models:** 2013 Chevrolet Express with 15 Passenger Seating (RPO ZP3)  
2013 GMC Savana with 15 Passenger Seating (RPO ZP3)

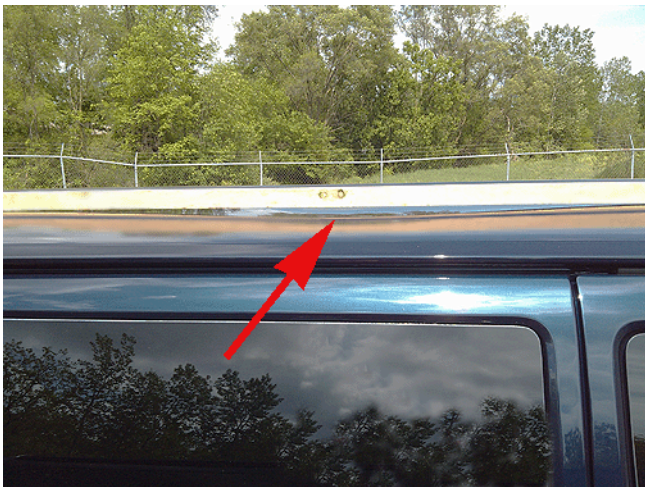
Some customers may comment that a sag/depression area appears on the roof of the vehicle at times and then goes away. This condition is most prevalent on dark colored vehicles. The affected area is 3 to 7 feet (0.9-2.1 m) from the rear edge of the roof with the deepest depression at 5 feet (1.5 m) from rear edge. The sag appears when the van is sitting outside in the sun and it will go away when van roof surface cools down but will re-appear when parked back in the sun. This sag is most prevalent on the passenger side of the vehicle. In some rare cases it may also appear on the driver side.

This condition is caused by an insufficient amount of (anti-flutter) sealer between the third and fourth roof bows and the outer panel. As the roof panel expands in the sunlight, the sealer does not expand as intended, causing the low areas to appear.

Use the following steps to remove the sealer (anti-flutter) in the affected area and install shim material.
