Service Bulletin

Subject: Excessive Oil Consumption – Perform Oil Consumption Test and/or Install Piston and Piston Ring Kit

Models: 2010-2013 Buick LaCrosse
2011-2013 Buick Regal
2010-2013 Chevrolet Equinox
2010-2013 GMC Terrain
Equipped with 2.4L Engine (RPOs LAF, LEA)

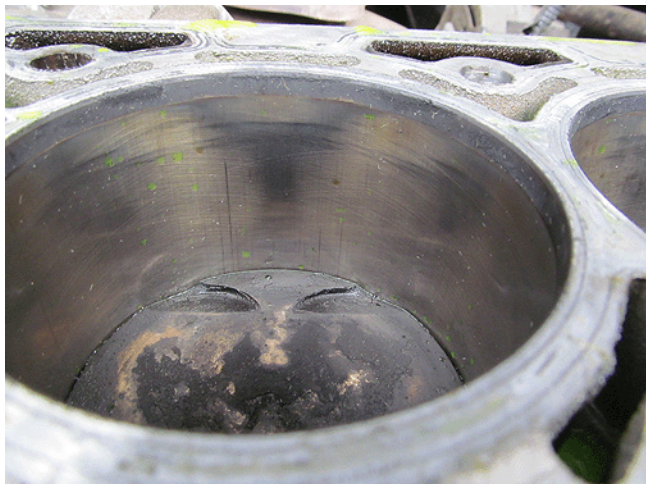
The repair is to replace the pistons and rings. In some cases the bore surface may not have a uniform look to the finish (zebra stripes) as shown below. As a result, some technicians may question whether the engine should be repaired or replaced. After careful evaluation, GM Powertrain has determined that the new pistons and rings will perform correctly in bores that have this appearance so engine replacement should not be necessary. The cylinder bores do not need any machine or honing work performed on them. Refer to the picture below for acceptable surface finishes.

Acceptable Cylinder that Does Not Appear Uniform (Zebra Stripes)

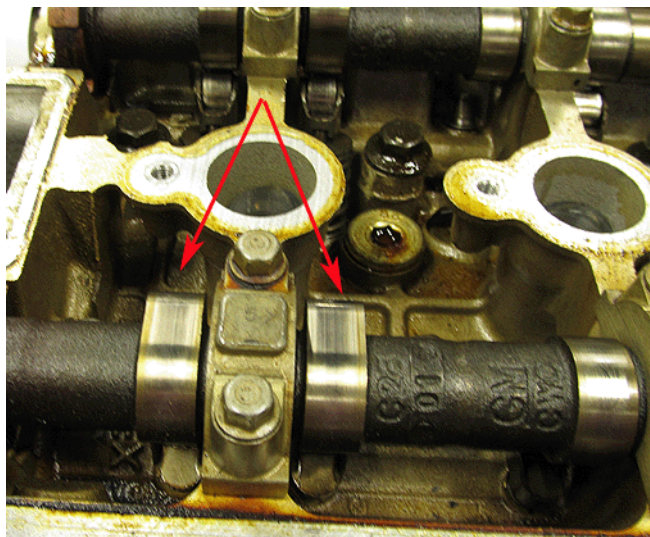
- Camshafts and roller follower will have wear markings. This is normal and do not need to be replaced (refer to picture above).
