Service Bulletin

PRELIMINARY INFORMATION

Subject: Radio Resets, Navigation Inoperative, Map Not Displayed, DVD Will Not Play or Resume, Bluetooth® Inoperable, Radio Lockup, Voice Recognition Cuts Off, USB Source not Returning to Last Song, OnStar® Default Volume Low

Models: 2013 Buick Enclave
2013 Chevrolet Traverse
2013 GMC Acadia
Equipped with Radio RPOs UHU, UG4, UGU, UGY, UGX

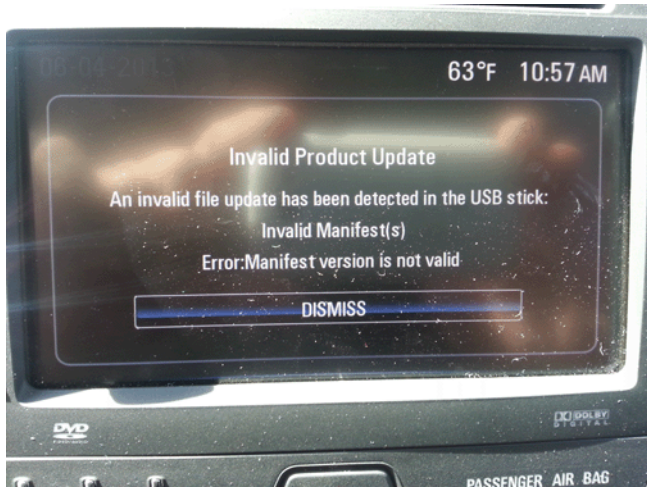
Note: If the following screen above is shown on the screen, the radio already has the latest calibration installed and no further action is required.

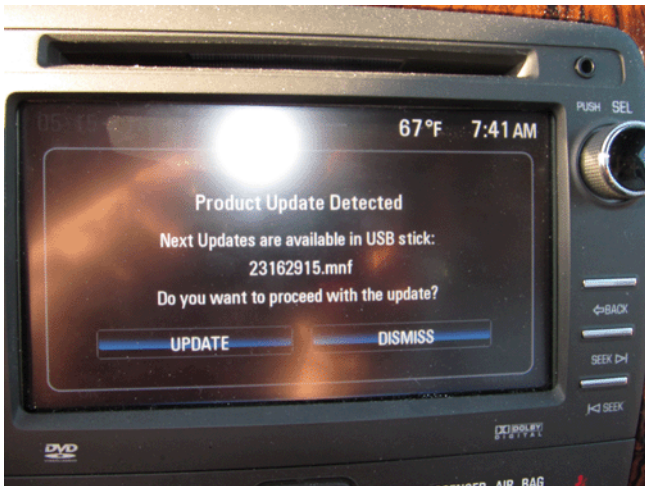
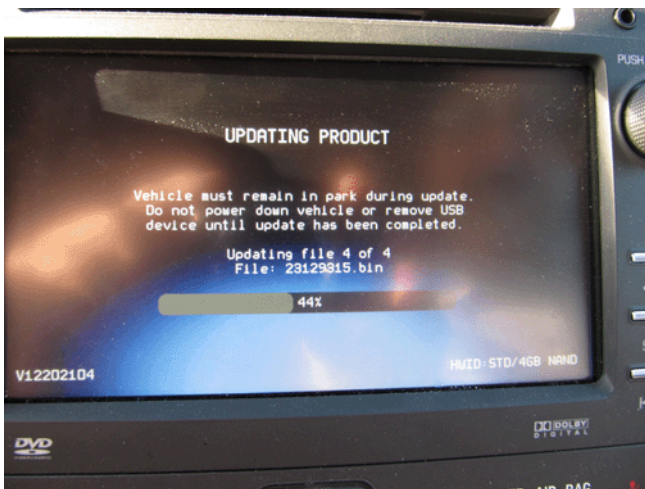
- Once Update has been selected from the display, the screen will show the progress of the update. The navigation software update will take up to 90 minutes to load. The non-navigation software will take up to 30 minutes to load.
- If "Invalid Product Update" message display with "Invalid Manifest(s)" error, the radio software is up to date. No update is required.

3. When the update info screen comes on, select UPDATE.

Note: If UPDATE is not selected within 10 seconds, the screen will disappear and the USB drive will have to be removed and inserted again to start the update process.
