Service Bulletin

Subject: Round Dark Stains on Roof Paint Center Rear Area

Models: 2010-2014 Chevrolet Equinox
2010-2014 GMC Terrain
All without RPO CF5 Sunroof

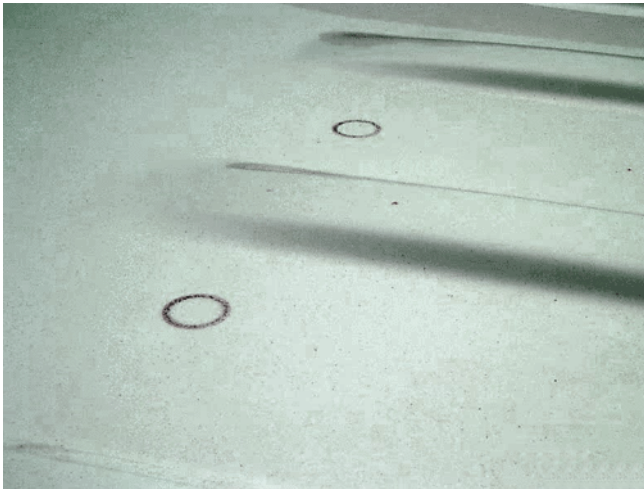
Some customers may comment that two dark circles of paint discoloration have formed in the center of the exterior roof panel. This condition is most noticeable on light colored vehicles.

This condition may be caused by the headliner retention magnets attracting steel or iron dust. This dust, combined with moisture, causes a dark/rust colored stain that does not wash off during routine vehicle washing.

Use the following steps to remove the stain and install two metal plates (latch striker spacers) inside of the roof. These metal plates will isolate the magnetic attraction from the exterior of the outer roof panel.
