## Garage door opener cannot be programmed or the range is too short

Topic number	LI68.05-P-049515
Version	5
Design group	68.05 Garage door opener
Date	02-12-2013
Validity	Models 164, 166, 172, 204, 207, 212, 216, 218, 221, 251 with code 231 or 232
Reason for change	Changed step 12 in remedy to include unsticking mirror buttons if there is no damage. Added complaint point
Reason for block

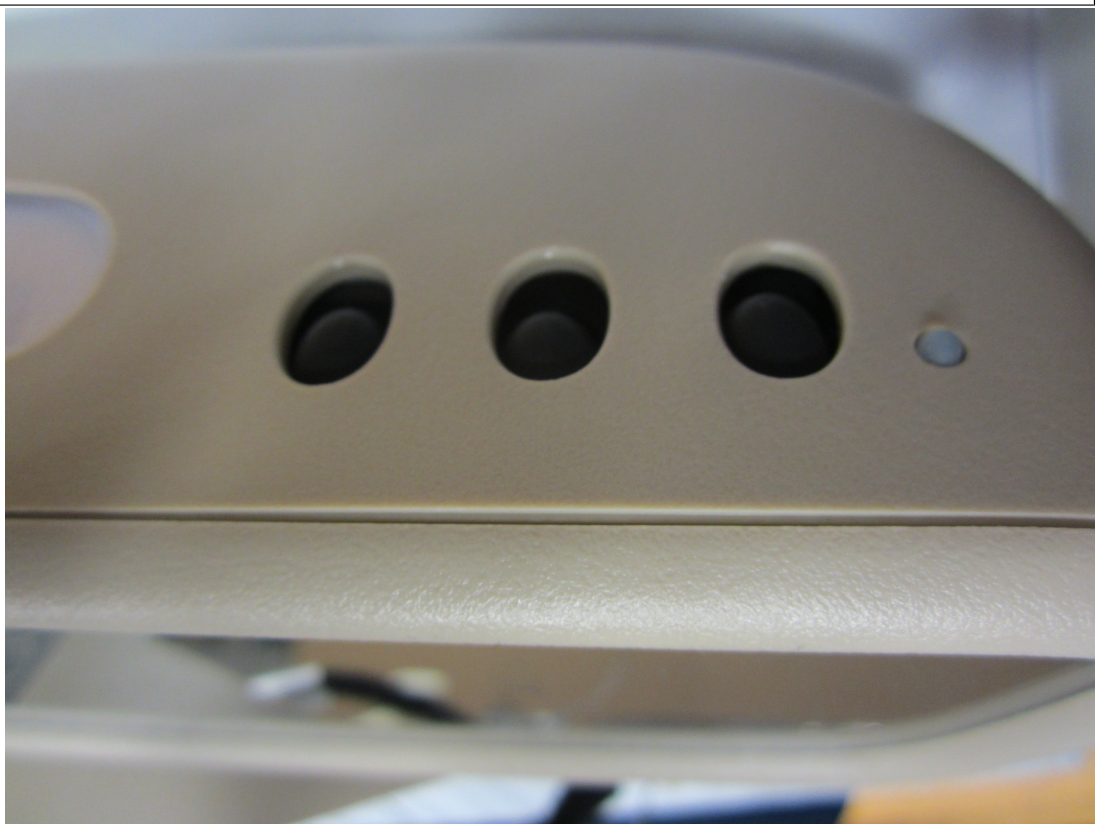
sticky\_buttons\_V2.JPG:

12. Stuck buttons: If, when supplied with power, the integrated garage door opener detects that one of the 3 buttons is sticking, this button is deactivated. The other buttons/memory slots still function. The function may be restored when the button stops sticking. This results in the entry of fault code B226901.

Attachments	
File	Designation
sticky_buttons_V2.JPG	Picture of buttons partially stuck in the mirror housing due to pressing hard and "rolling" the buttons on the mirror.

12. If buttons are only partially stuck within the mirror housing (see sticky\_buttons\_V2.JPG attachment), please carefully unstick the buttons and inform the customer that pressing very hard on the buttons is not necessary. If there is damage to the mirror buttons where unsticking the buttons will not help, replace garage door opener/inside rearview mirror.
